# ECISD Richard R. Flores Structural Repair - Mar 1, 2022

Prepared by Simon Solorio

Mar 7, 2022

Field observations.

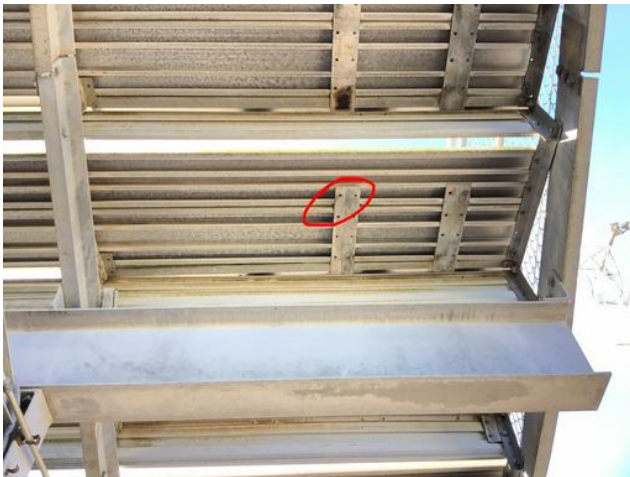
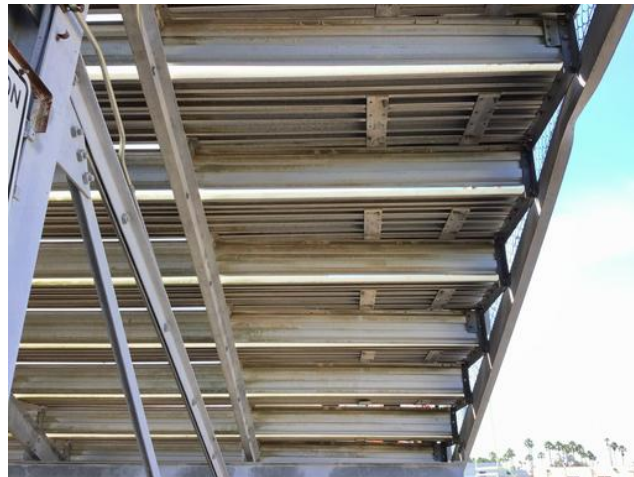
Missing Screws

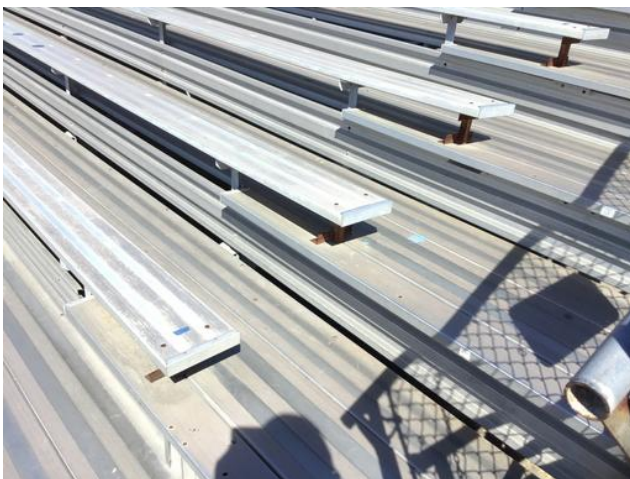
20220301\_143724\_photo

Design >  
Improper use of material  
type

Red iron used instead of  
aluminum. Red iron is  
corroding

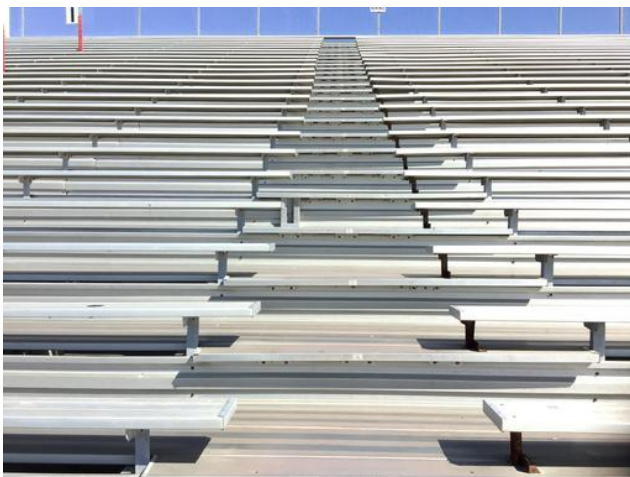
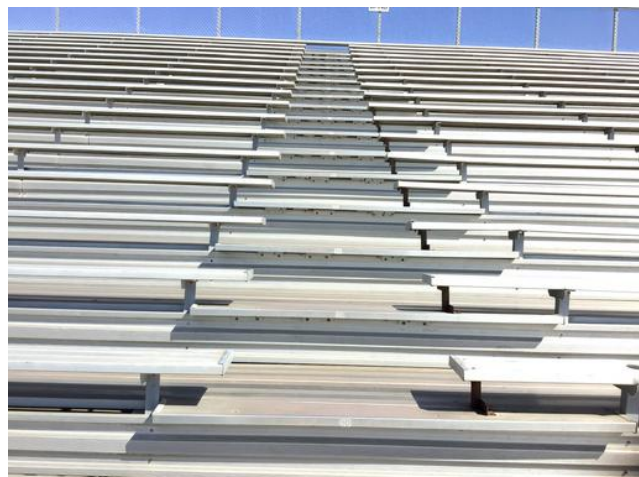
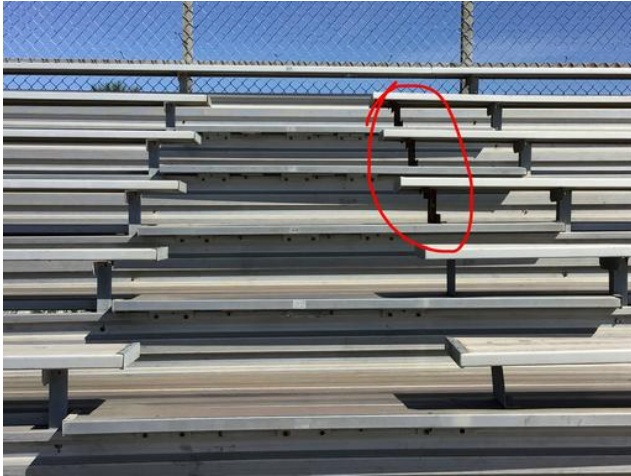
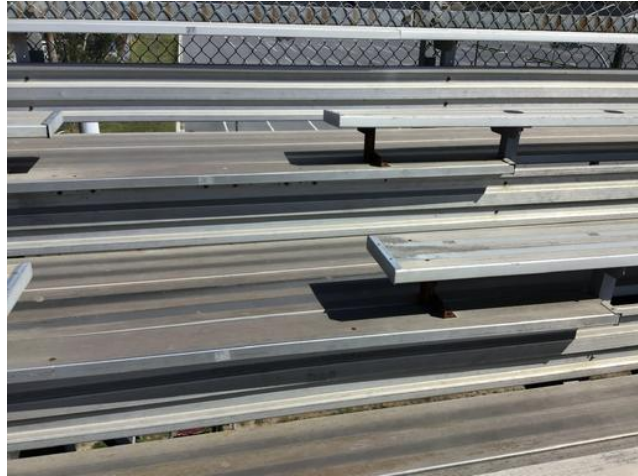
Design >  
Improper use of material  
type

Red iron used instead of  
aluminum. Red iron is  
corroding

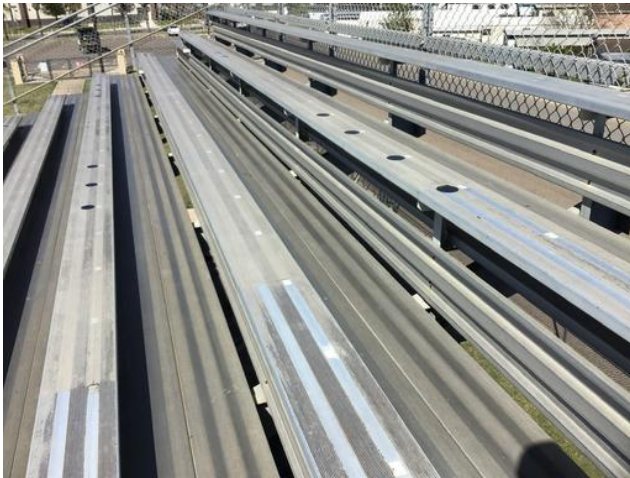
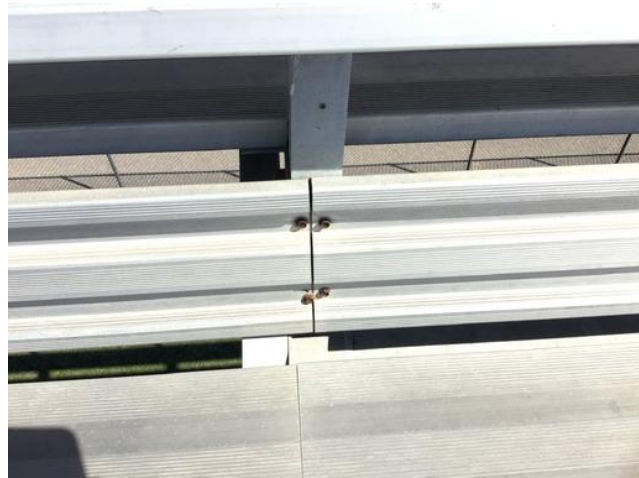
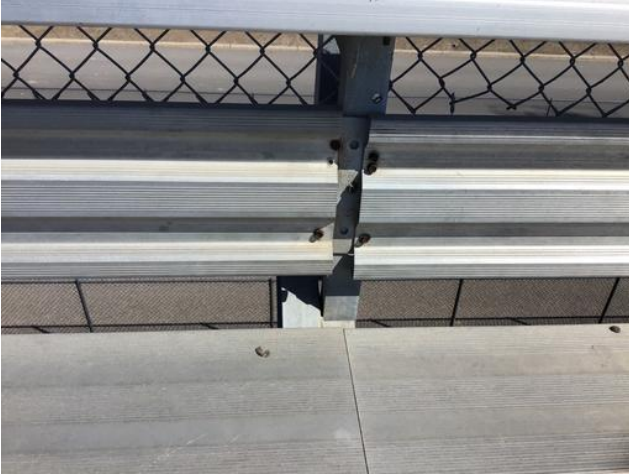
Design >  
Improper use of material  
type

Screws are corroding

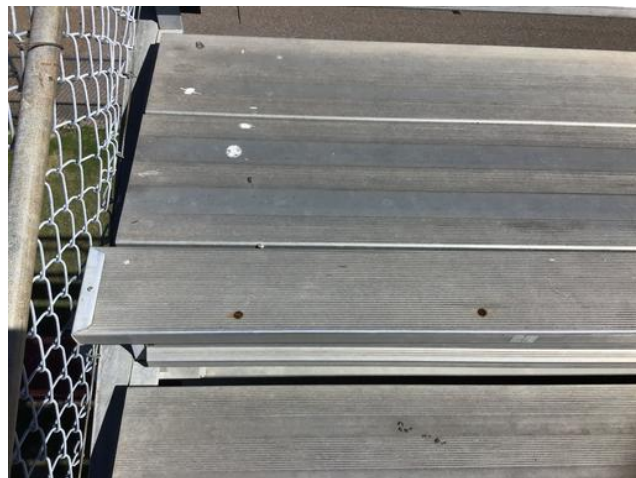
20220301\_142958\_photo

Design >  
Improper use of material  
type

Screws rusted

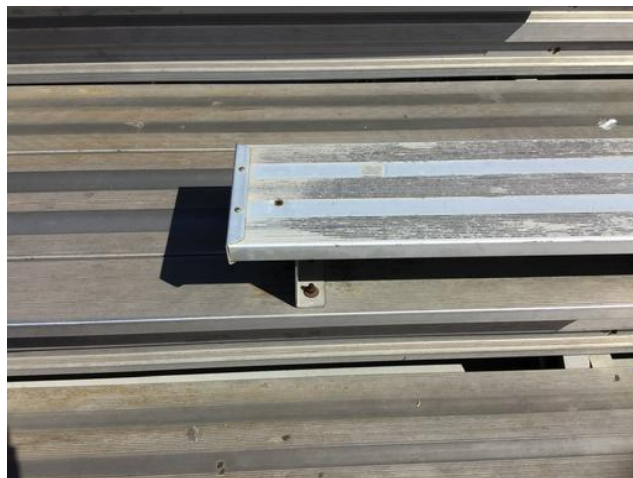
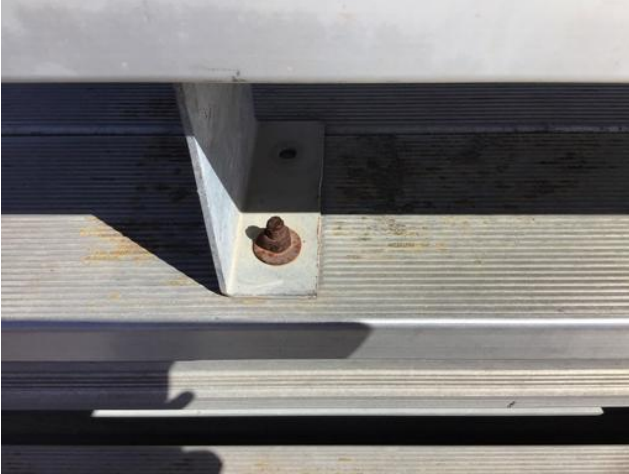
Design >  
Improper use of material  
type

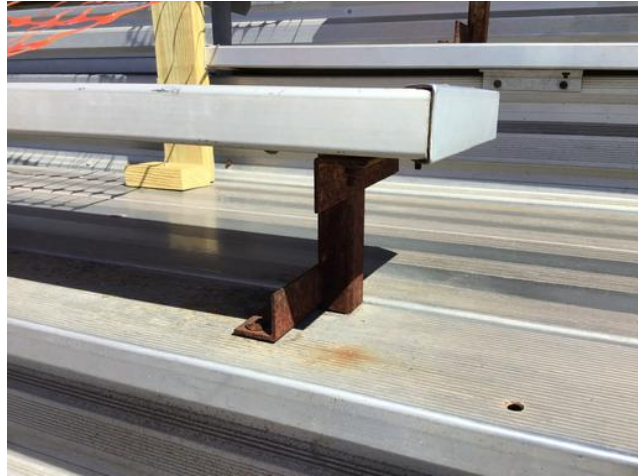
**Root Cause**  
Design >  
Improper use of material  
type

**Description**  
27.  
Support is corroding

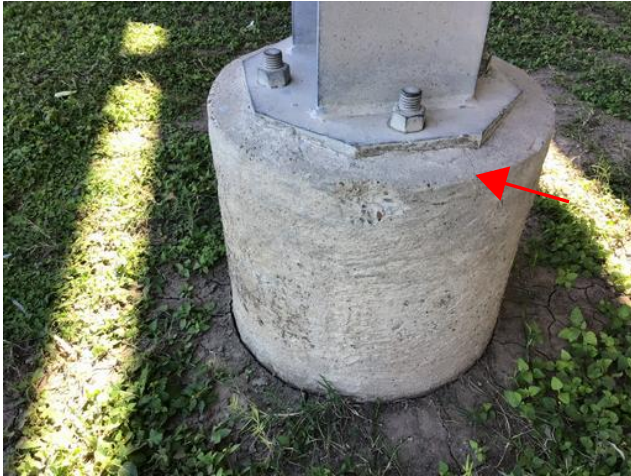
20220301\_141559\_photo  
**Simon Solorio**  
Mar 1, 2022 2:16 PM

Design >  
Design and/or construction  
deficiency

Concrete pedestal, shear  
failure and lack of  
confinement of vertical  
reinforcing and anchor bolts.

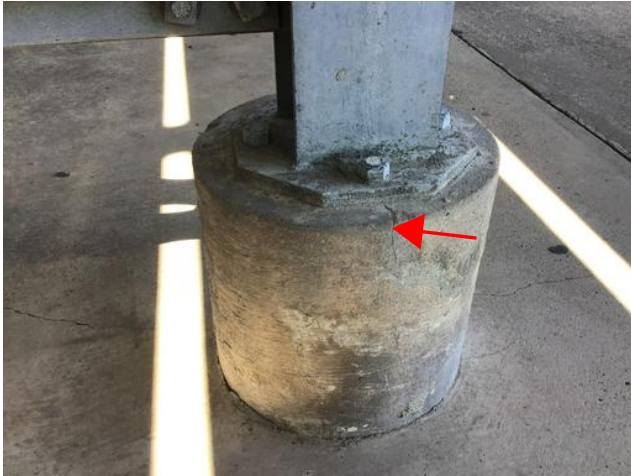
20220301\_140841\_photo

Design >  
Design and/or construction  
deficiency

Concrete pedestal, shear  
failure and lack of  
confinement of vertical  
reinforcing and anchor bolts.

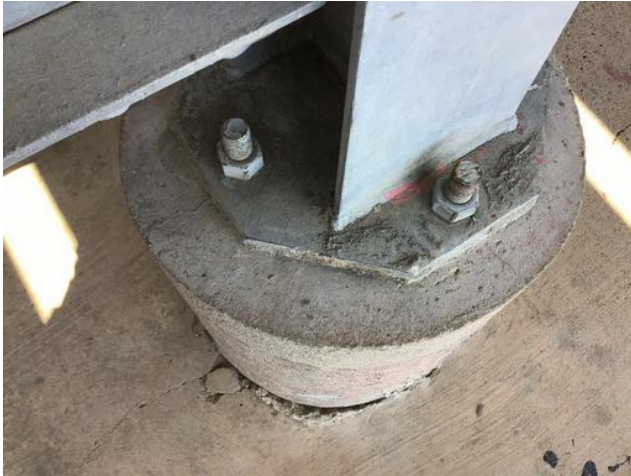
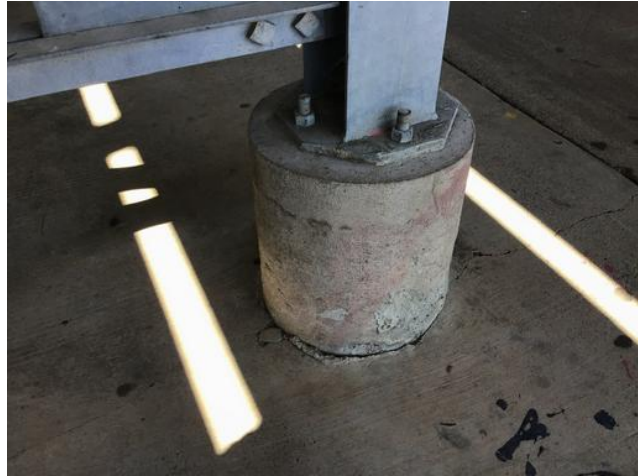
Design >  
Design and/or construction  
deficiency

Concrete pedestal, shear  
failure and lack of  
confinement of vertical  
reinforcing and anchor bolts.

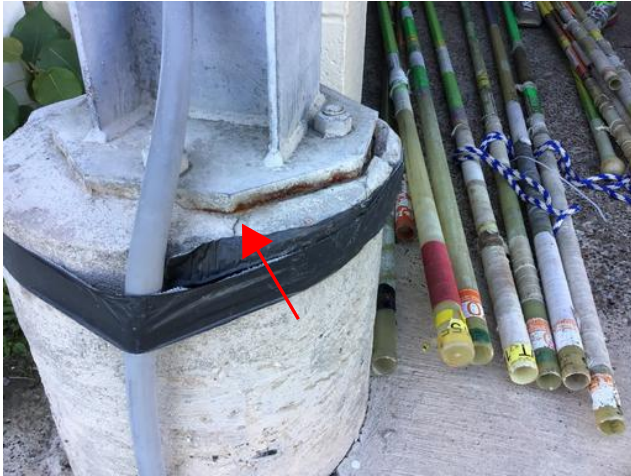
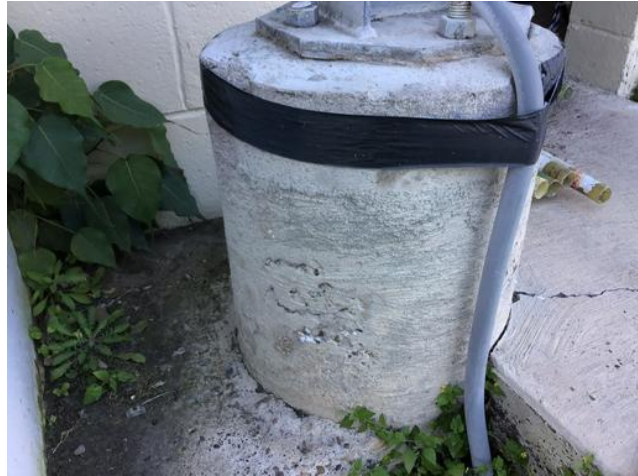
Design >  
Design and/or construction  
deficiency

Concrete pedestal, shear  
failure and lack of  
confinement of vertical  
reinforcing and anchor bolts.

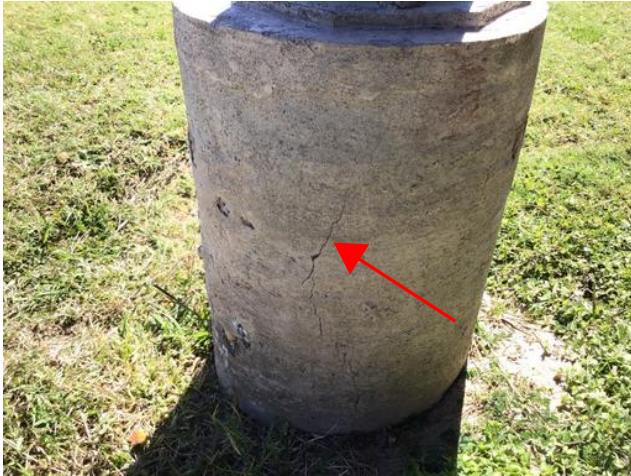
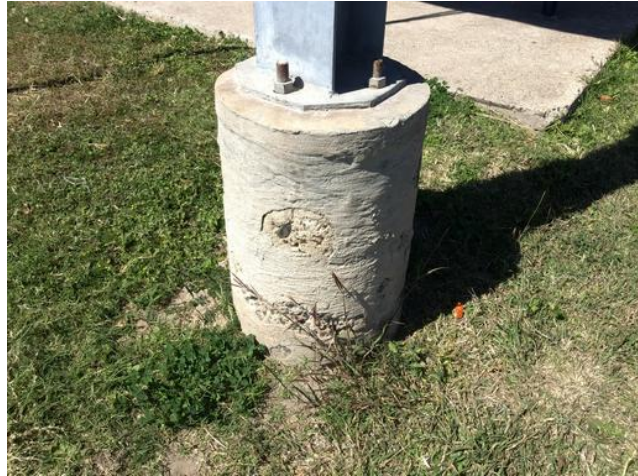
Design >  
Design and/or construction  
deficiency

Concrete pedestal, shear  
failure and lack of  
confinement of vertical  
reinforcing and anchor bolts.

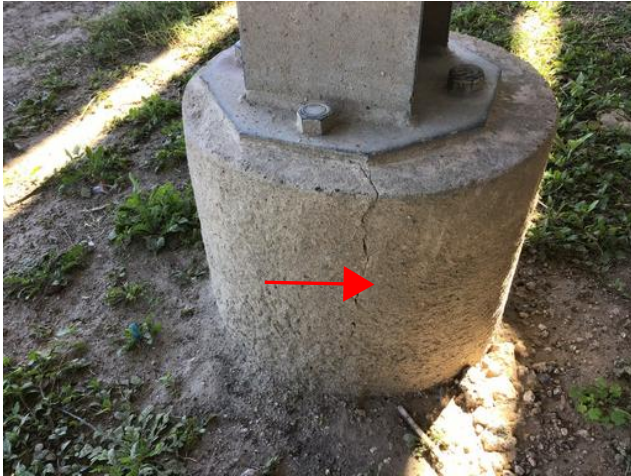
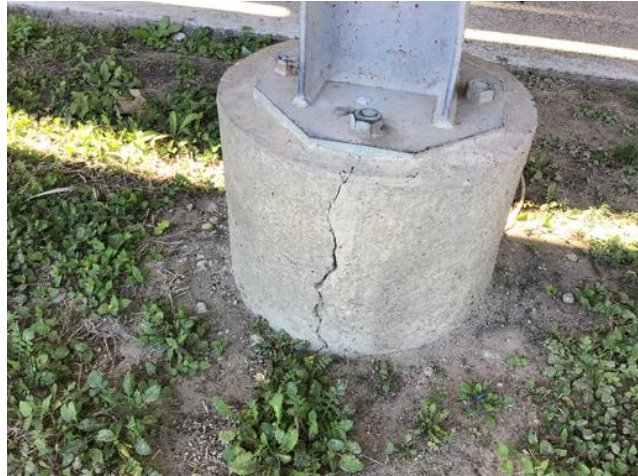
Design >  
Design and/or construction  
deficiency

Concrete pedestal, shear  
failure and lack of  
confinement of vertical  
reinforcing and anchor bolts.

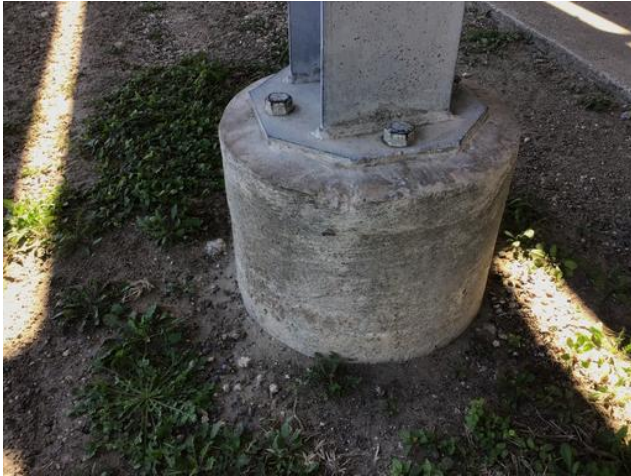
20220301\_135123\_photo  
**Simon Solorio**  
Mar 1, 2022 1:51 PM

## #79 Spalled Concrete Pedastal

Concrete pedestal, shear  
failure and lack of  
confinement of vertical  
reinforcing and anchor bolts.

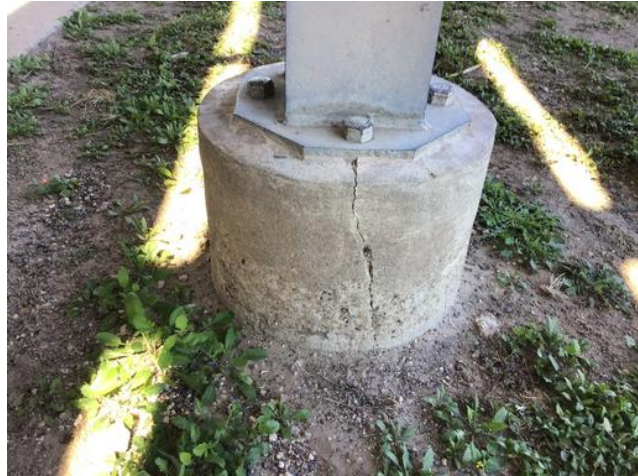
Design >  
Design and/or construction  
deficiency

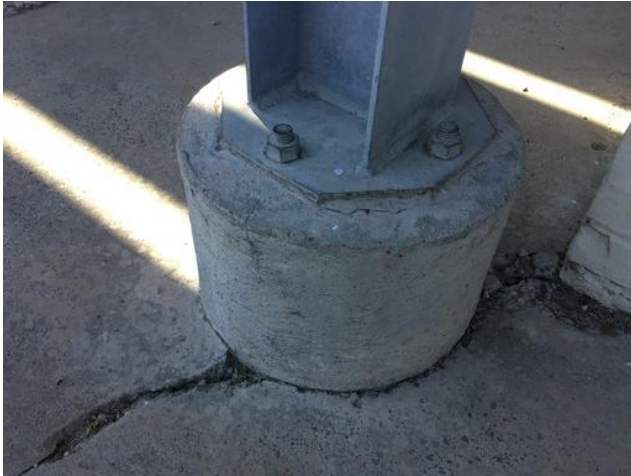
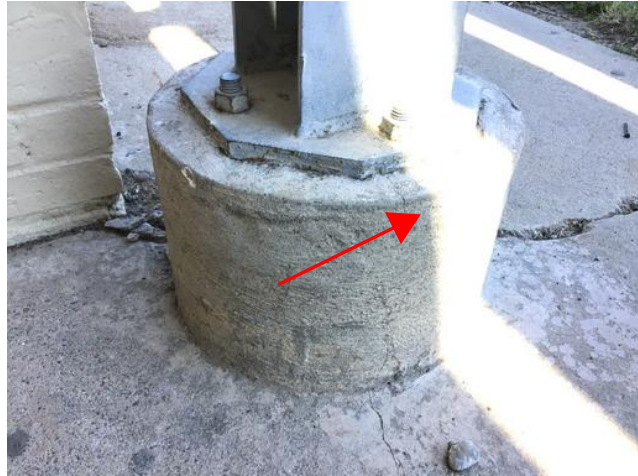
20220301\_135037\_photo

## #78 Spalled Concrete Pedastal

Concrete pedestal, shear  
failure and lack of  
confinement of vertical  
reinforcing and anchor bolts.

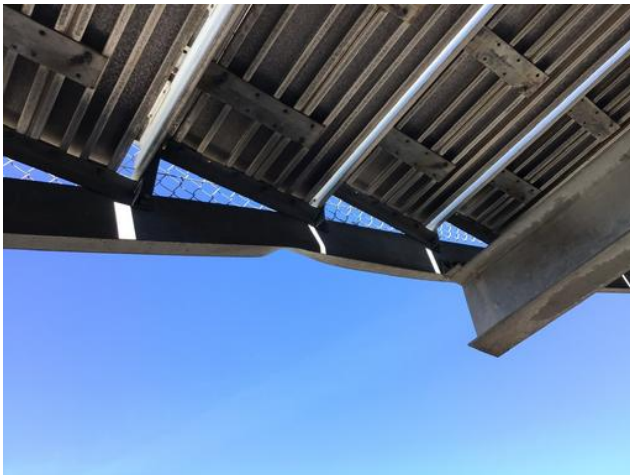
20220301\_134920\_photo

Steel member is damaged,  
bent

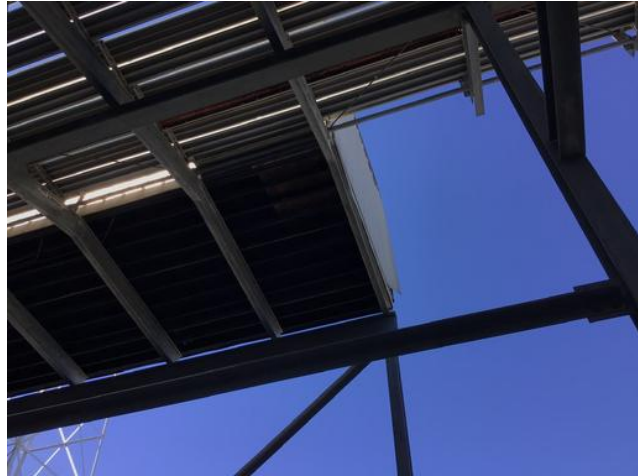
Plywood exposed, metal panel is loose/missing

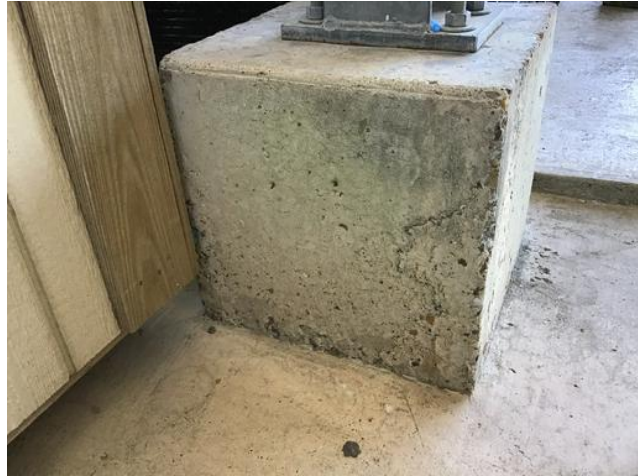
## #75 Spalled Concrete Pedastal

Design >  
Design and/or construction  
deficiency

Concrete pedestal, shear  
failure and lack of  
confinement of vertical  
reinforcing and anchor bolts.

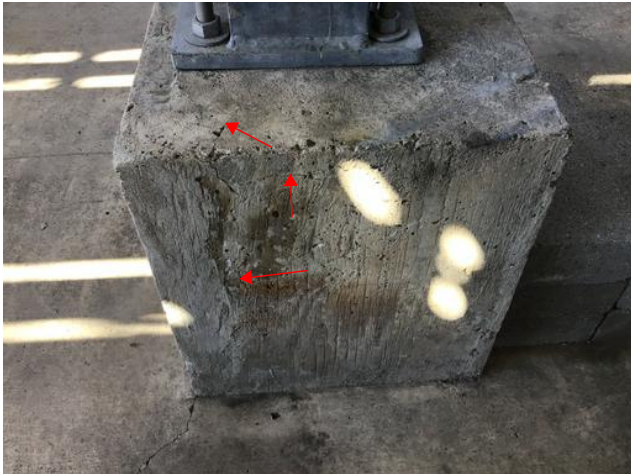
## #72 Spalled Concrete Pedestal

Design >  
Design and/or construction  
deficiency

Concrete pedestal, shear  
failure and lack of  
confinement of vertical  
reinforcing and anchor bolts.

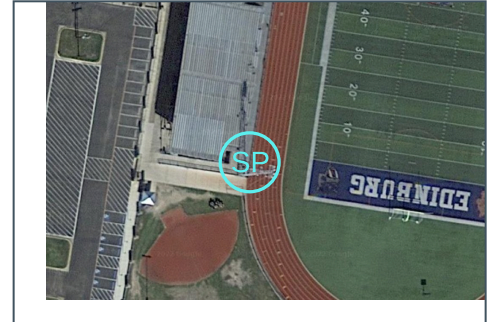
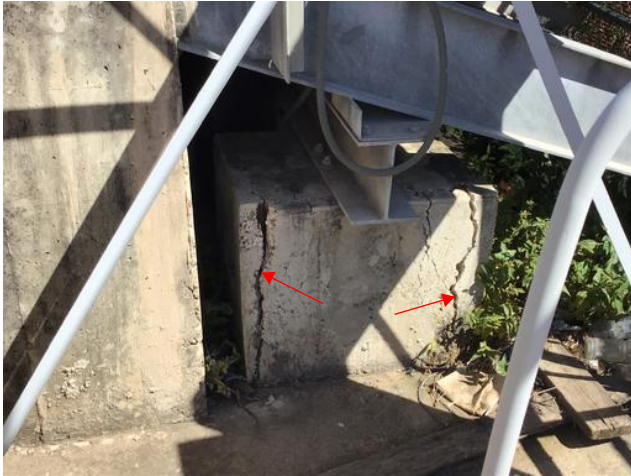
20220301\_111314\_photo

## #71 Spalled Concrete Pedastal

Concrete pedestal, shear  
failure and lack of  
confinement of vertical  
reinforcing and anchor bolts.

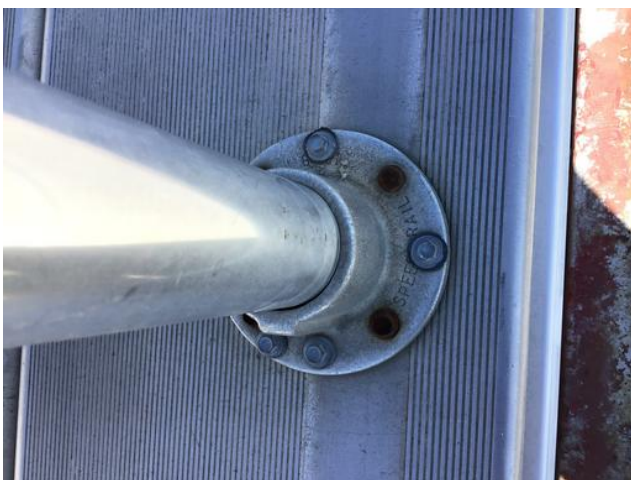
20220301\_110841\_photo

Incorrect screws used

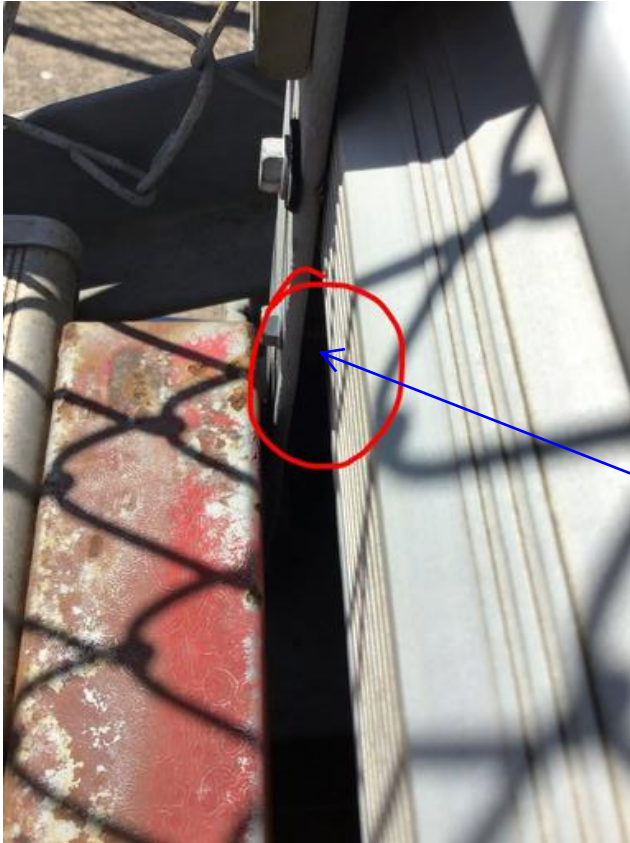
20220301\_110745\_photo  
**Simon Solorio**  
Mar 1, 2022 11:07 AM

Gab between aluminum footer and support frame

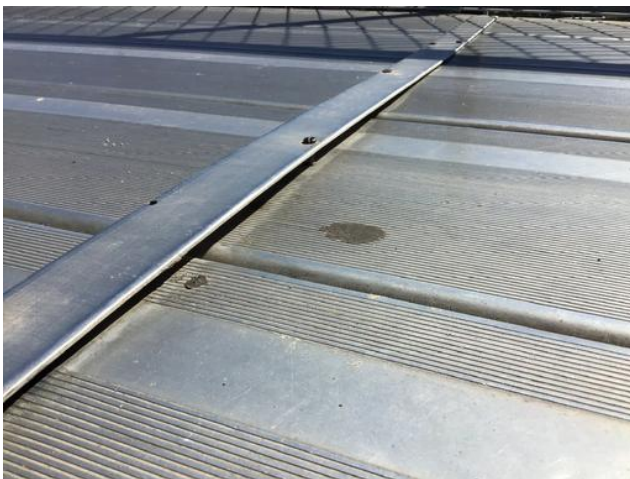
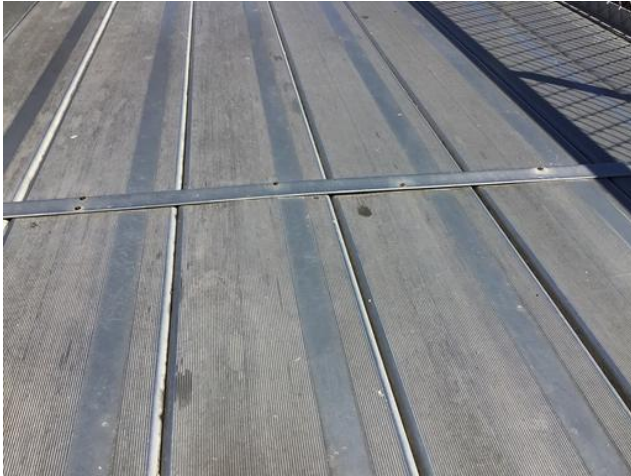
20220301\_110551\_photo

Screws sheared, needs to  
be replaced

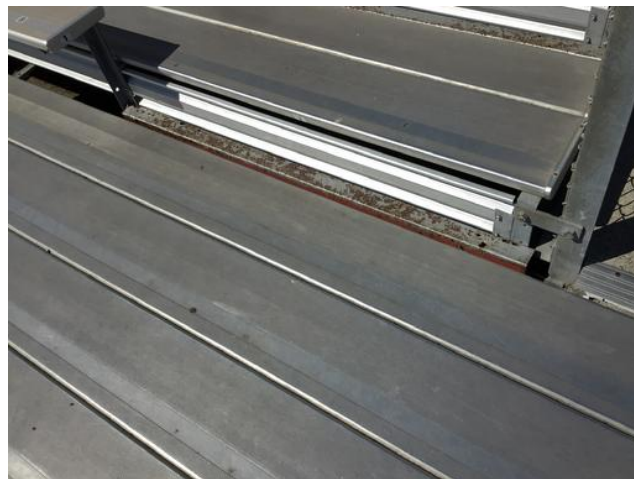
20220301\_110345\_photo  
**Simon Solorio**  
Mar 1, 2022 11:03 AM

Footer used is not aluminum  
and has corroded

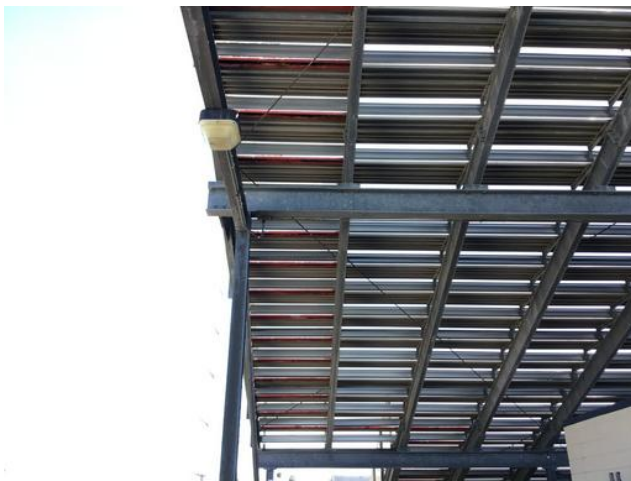
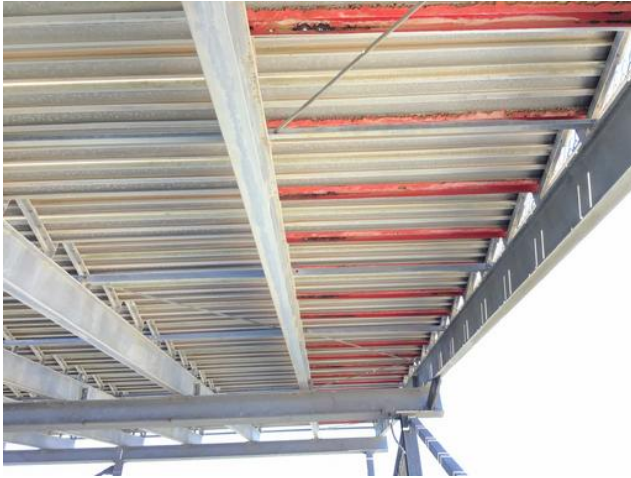
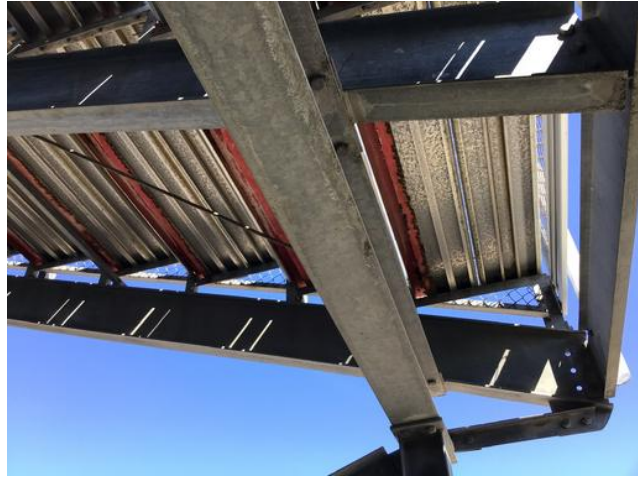
20220301\_105843\_photo  
**Simon Solorio**  
Mar 1, 2022 10:58 AM

## #65 Angle

24 Footer used is not  
aluminum and has corroded

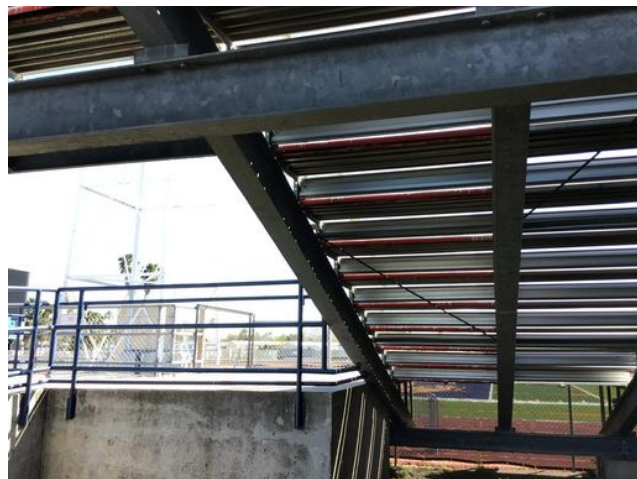
20220301\_105726\_photo  
Simon Solorio  
Mar 1, 2022 10:57 AM

## #64 Angle

13 Footer used is not  
aluminum and has corroded

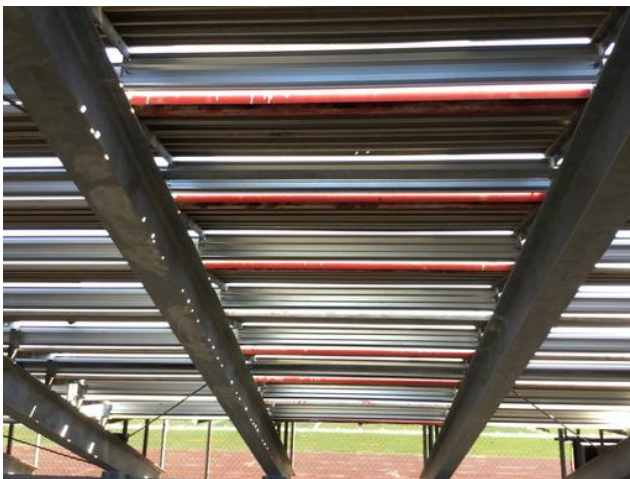
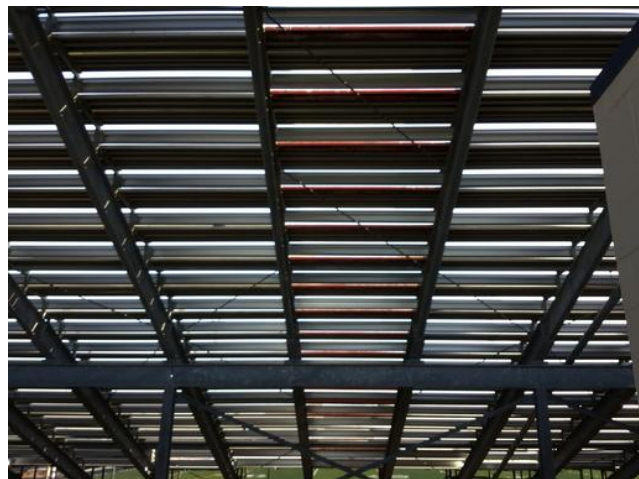
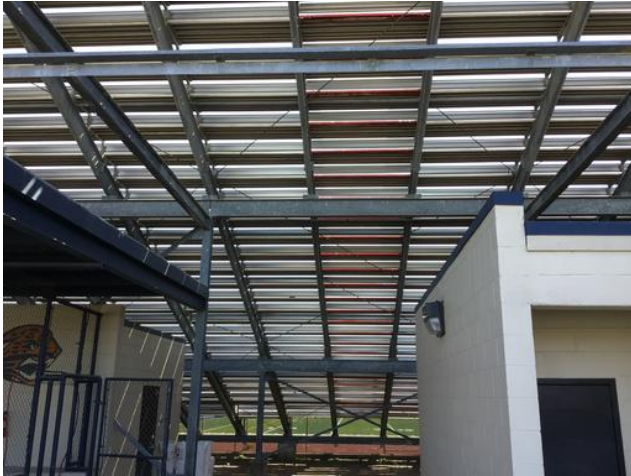
20220301\_105653\_photo  
Simon Solorio  
Mar 1, 2022 10:56 AM

## #63 Angle

32 Footer used is not  
aluminum and has corroded

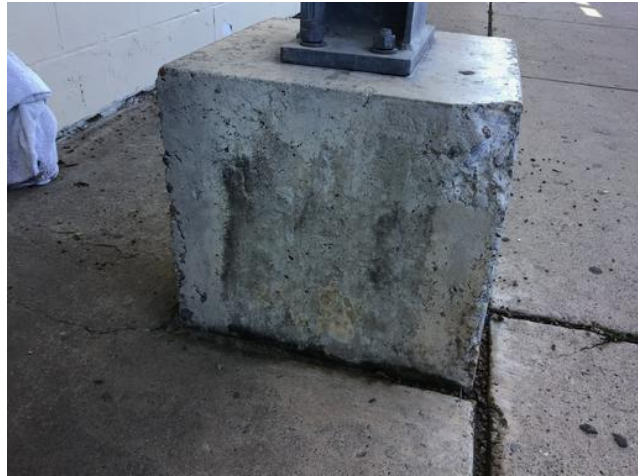
## #58 Spalled Concrete Pedastal

Design >  
Design and/or construction  
deficiency

Concrete pedestal, shear  
failure and lack of  
confinement of vertical  
reinforcing and anchor bolts.

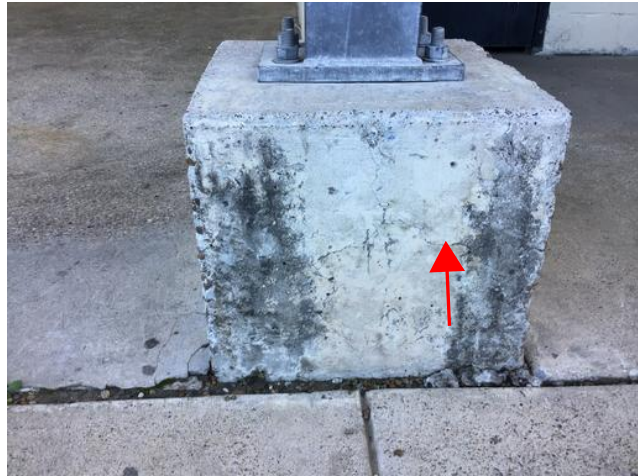
## #57 Spalled Concrete Pedestal

Design >  
Design and/or construction  
deficiency

Concrete pedestal, shear  
failure and lack of  
confinement of vertical  
reinforcing and anchor bolts.

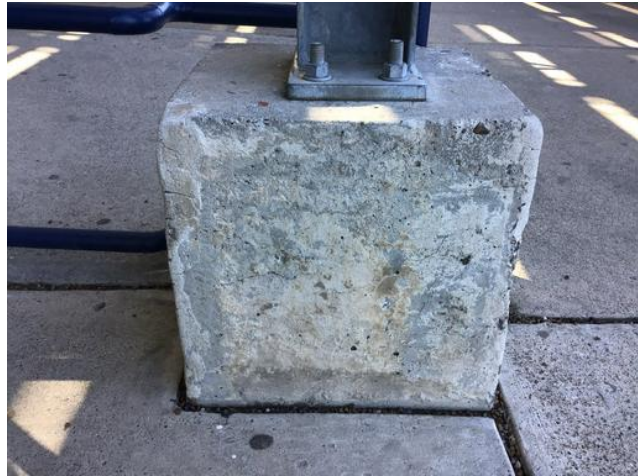
## #56 Spalled Concrete Pedastal

Design >  
Design and/or construction  
deficiency

Concrete pedestal, shear  
failure and lack of  
confinement of vertical  
reinforcing and anchor bolts.

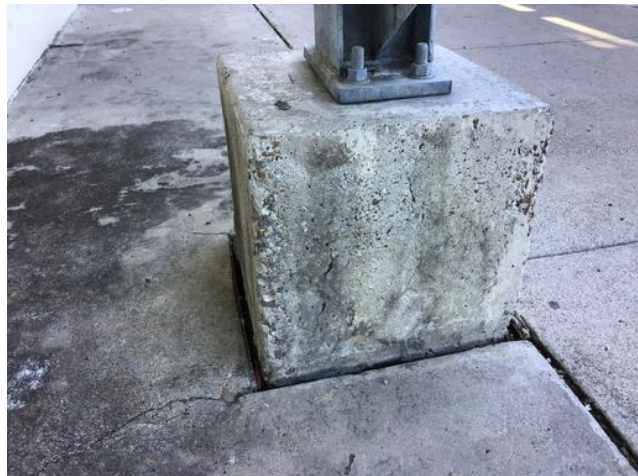
## #55 Spalled Concrete Pedastal

Design >  
Design and/or construction  
deficiency

Concrete pedestal, shear  
failure and lack of  
confinement of vertical  
reinforcing and anchor bolts.

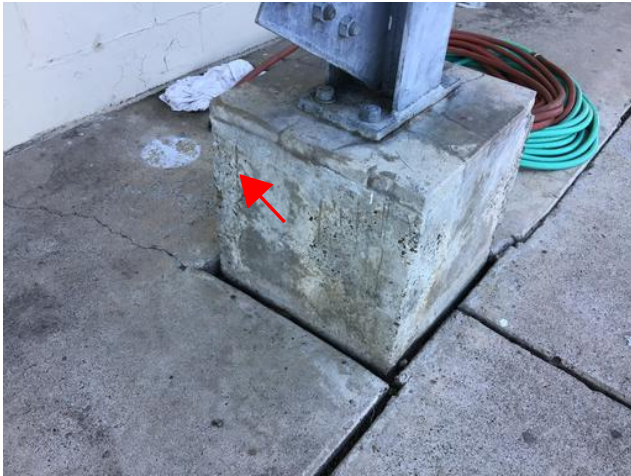
## #54 Spalled Concrete Pedastal

Design >  
Design and/or construction  
deficiency

Concrete pedestal, shear  
failure and lack of  
confinement of vertical  
reinforcing and anchor bolts.

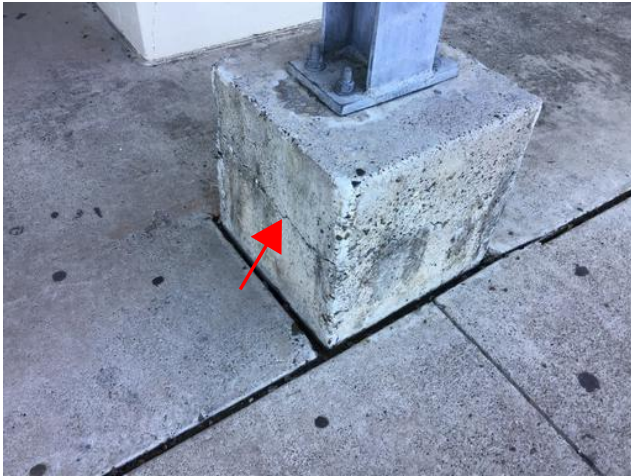
## #53 Spalled Concrete Pedastal

Design >  
Design and/or construction  
deficiency

Concrete pedestal, shear  
failure and lack of  
confinement of vertical  
reinforcing and anchor bolts.

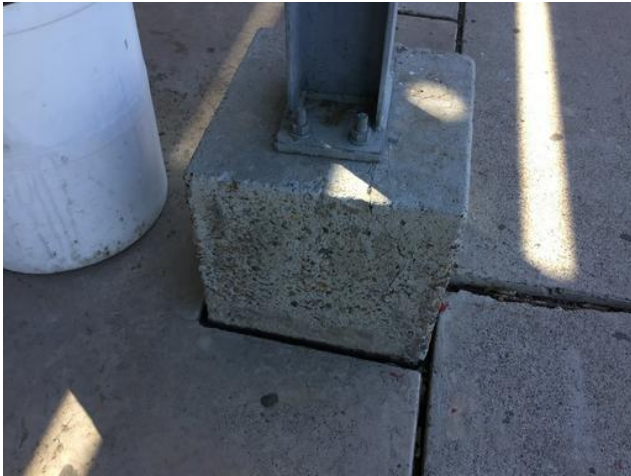
## #52 Spalled Concrete Pedastal

Design >  
Design and/or construction  
deficiency

Concrete pedestal, shear  
failure and lack of  
confinement of vertical  
reinforcing and anchor bolts.

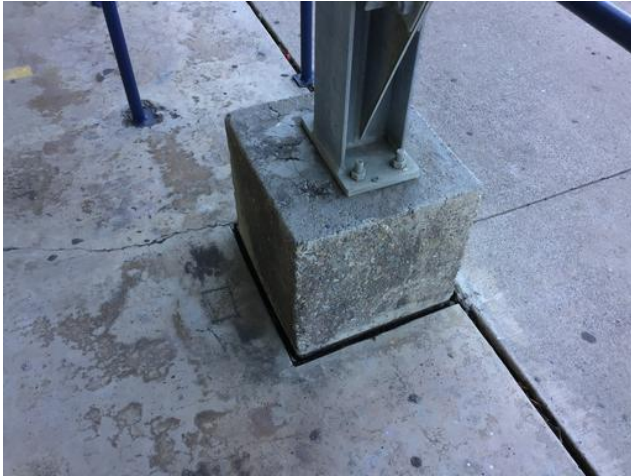
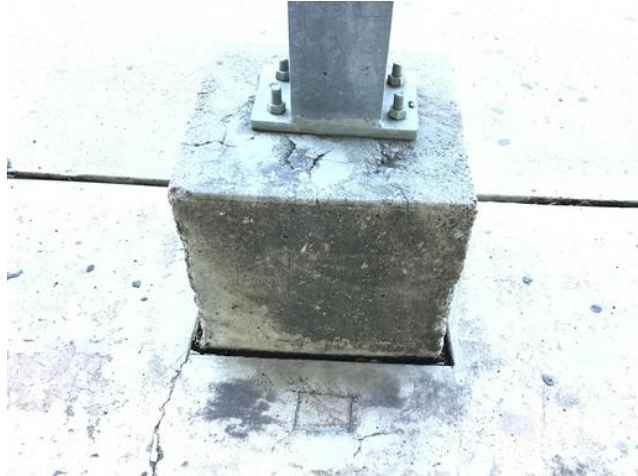
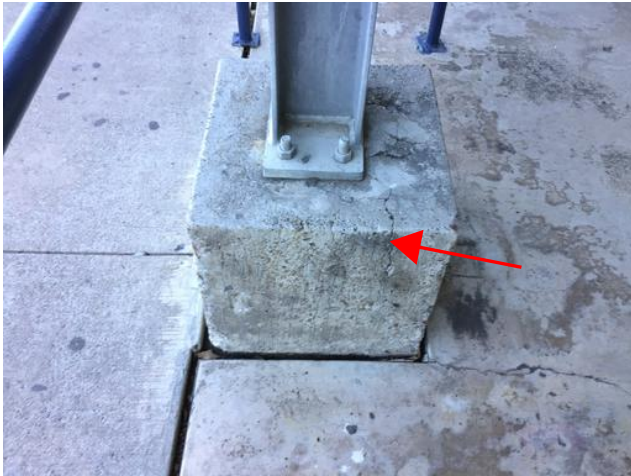
## #51 Spalled Concrete Pedastal

Design >  
Design and/or construction  
deficiency

Concrete pedestal, shear  
failure and lack of  
confinement of vertical  
reinforcing and anchor bolts.

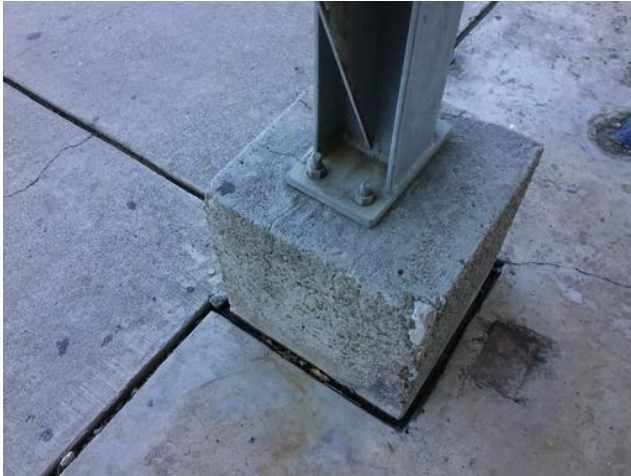
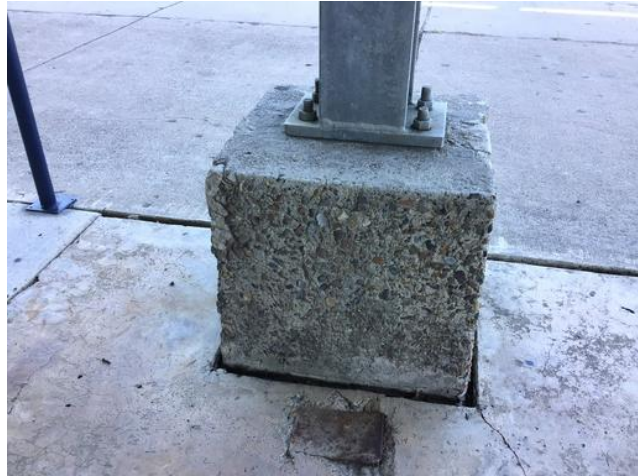
## #50 Spalled Concrete Pedastal

Design >  
Design and/or construction  
deficiency

Concrete pedestal, shear  
failure and lack of  
confinement of vertical  
reinforcing and anchor bolts.

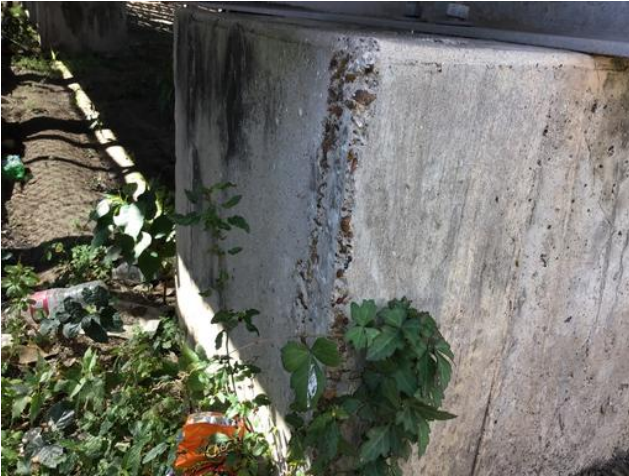
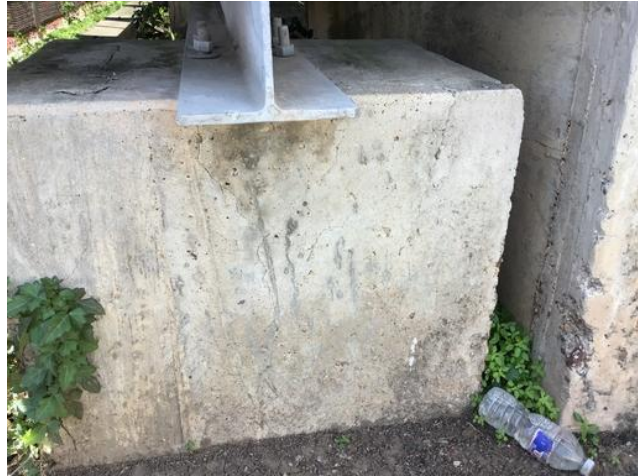
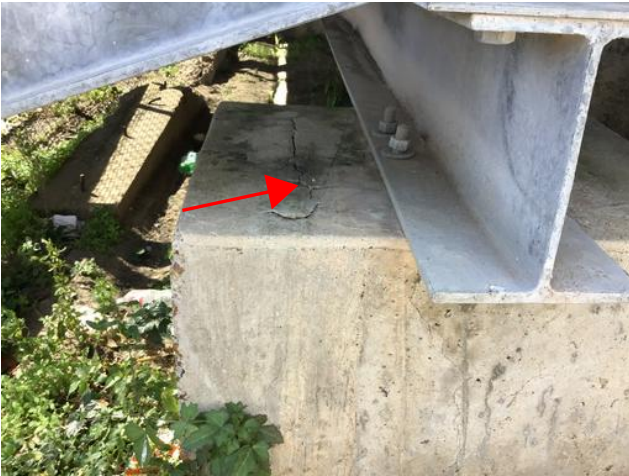
## #49 Spalled Concrete Pedastal

Design >  
Design and/or construction  
deficiency

Concrete pedestal, shear  
failure and lack of  
confinement of vertical  
reinforcing and anchor bolts.

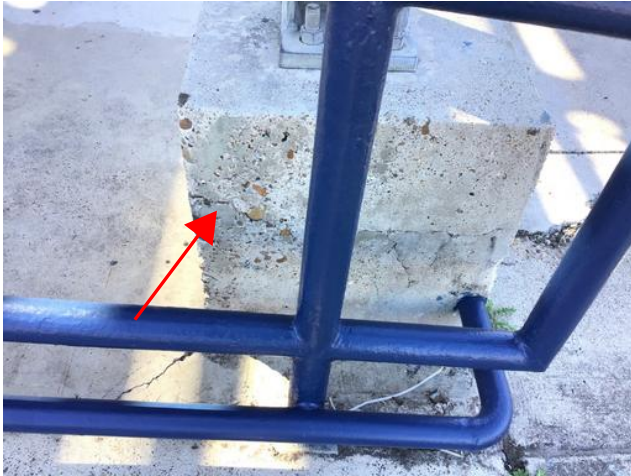
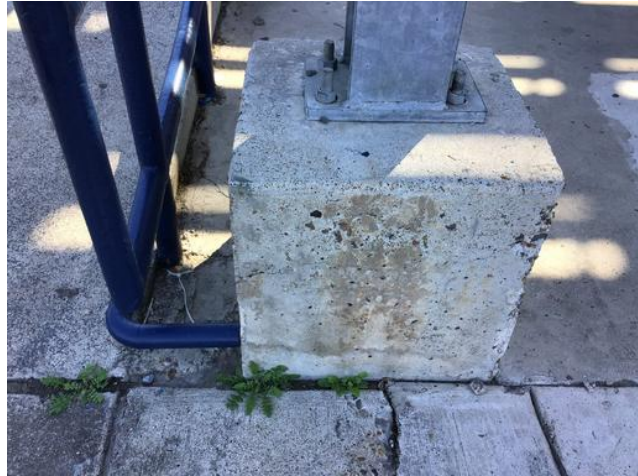
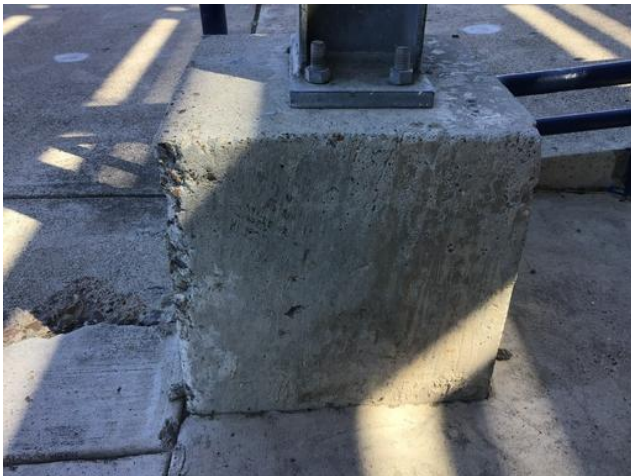
## #48 Spalled Concrete Pedastal

Design >  
Design and/or construction  
deficiency

Concrete pedestal, shear  
failure and lack of  
confinement of vertical  
reinforcing and anchor bolts.

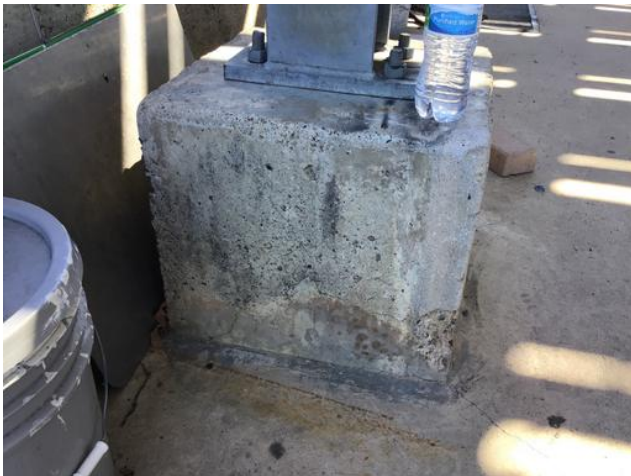
## #47 Spalled Concrete Pedastal

Design >  
Design and/or construction  
deficiency

Concrete pedestal, shear  
failure and lack of  
confinement of vertical  
reinforcing and anchor bolts.

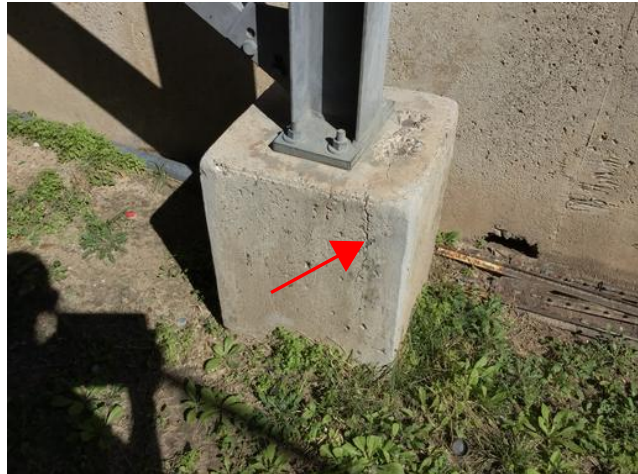
## #46 Spalled Concrete Pedestal

Design >  
Design and/or construction  
deficiency

Concrete pedestal, shear  
failure and lack of  
confinement of vertical  
reinforcing and anchor bolts.

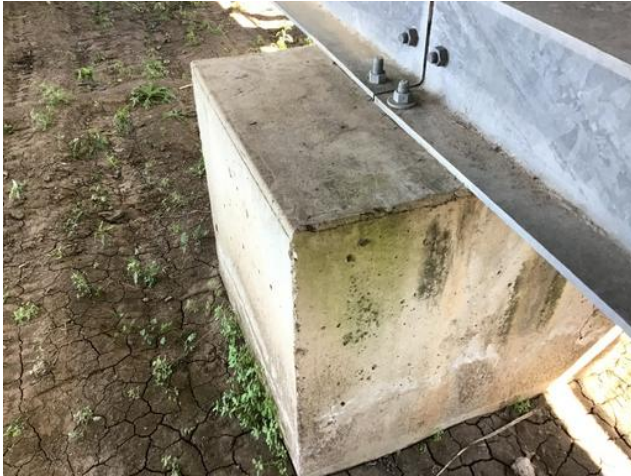
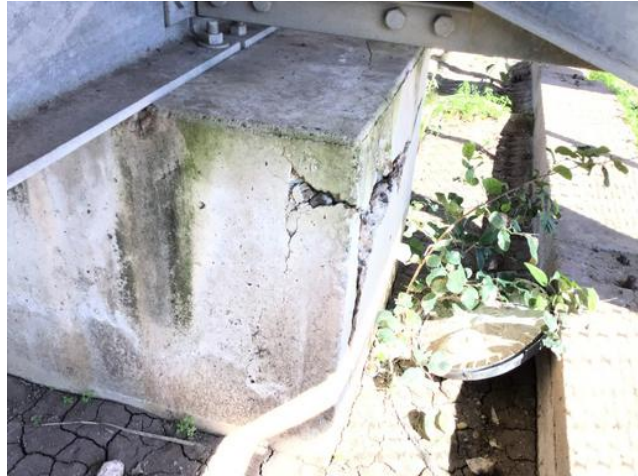
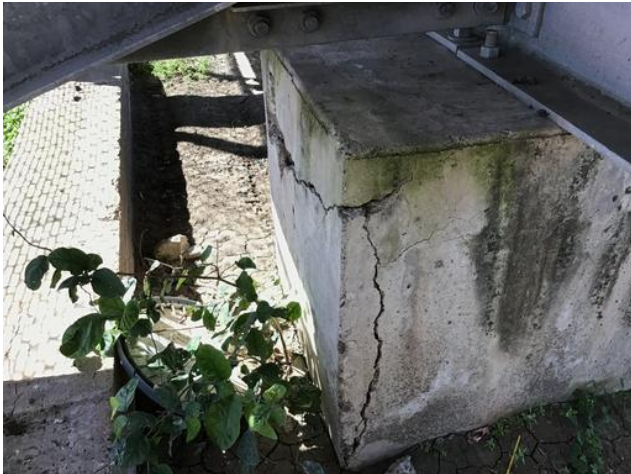
## #45 Spalled Concrete Pedestal

Design >  
Design and/or construction  
deficiency

Concrete pedestal, shear  
failure and lack of  
confinement of vertical  
reinforcing and anchor bolts.
