# ECISD Richard R. Flores Structural Repair - Mar 1, 2022

Prepared by Simon Solorio

Mar 7, 2022

Field observations.

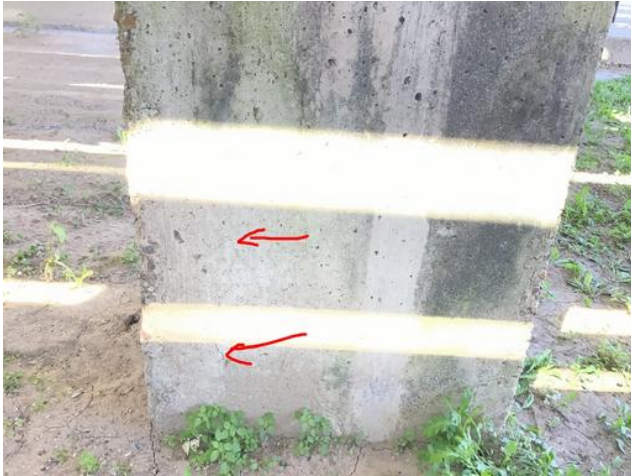
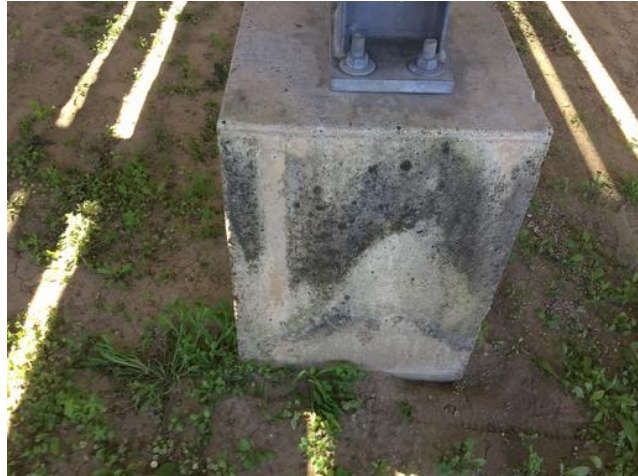
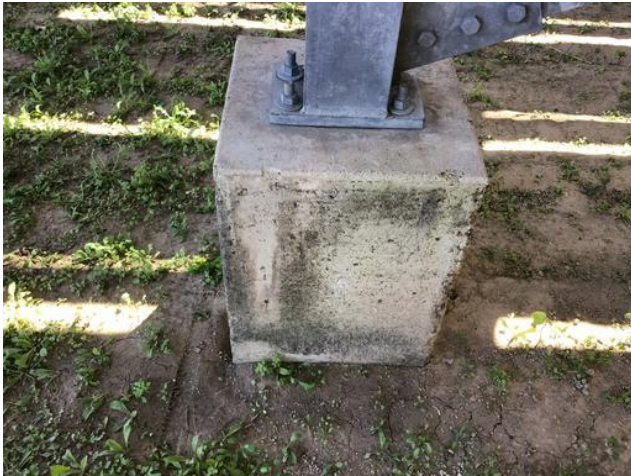
## #44 Spalled Concrete Pedestal

Damage

Design >  
Design and/or construction  
deficiency

Concrete pedestal, shear  
failure and lack of  
confinement of vertical  
reinforcing and anchor bolts.

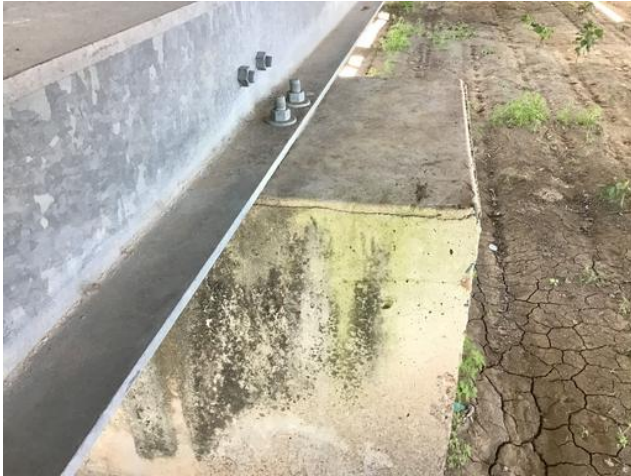
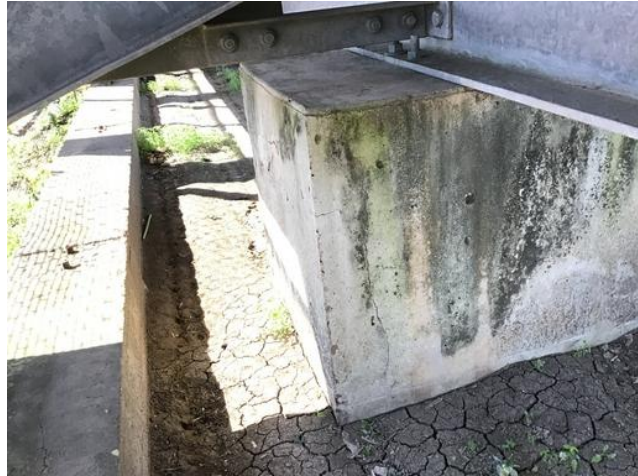
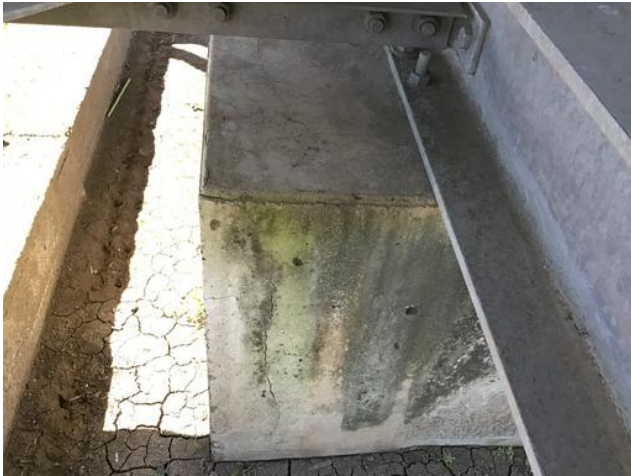
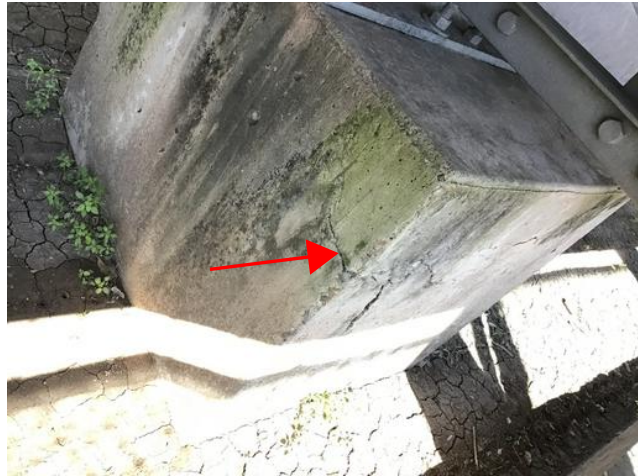
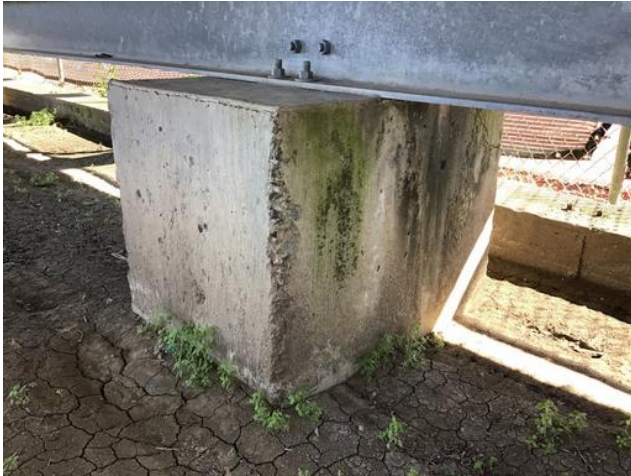
## #43 Spalled Concrete Pedastal

Damage

Design >  
Design and/or construction  
deficiency

Concrete pedestal, shear  
failure and lack of  
confinement of vertical  
reinforcing and anchor bolts.

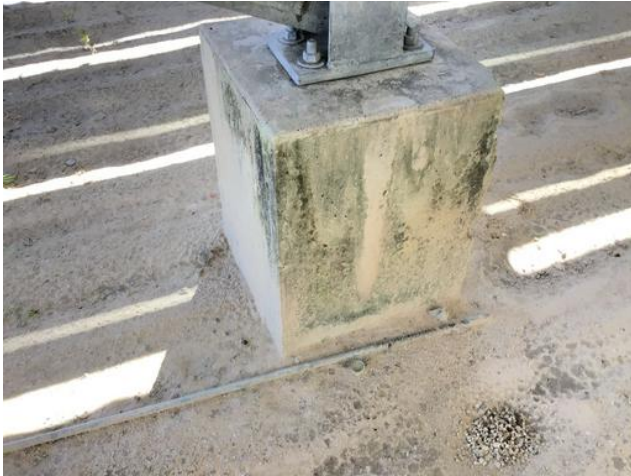
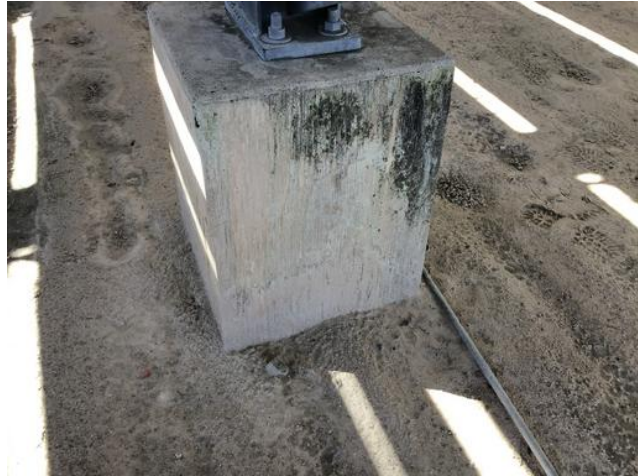
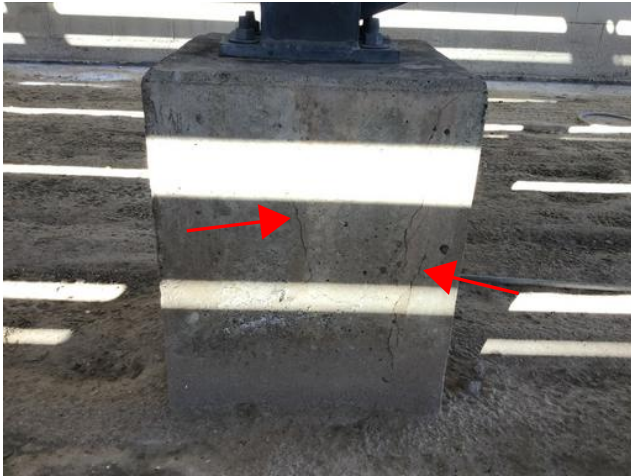
## #42 Spalled Concrete Pedastal

Damage

Design >  
Design and/or construction  
deficiency

Concrete pedestal, shear  
failure and lack of  
confinement of vertical  
reinforcing and anchor bolts.

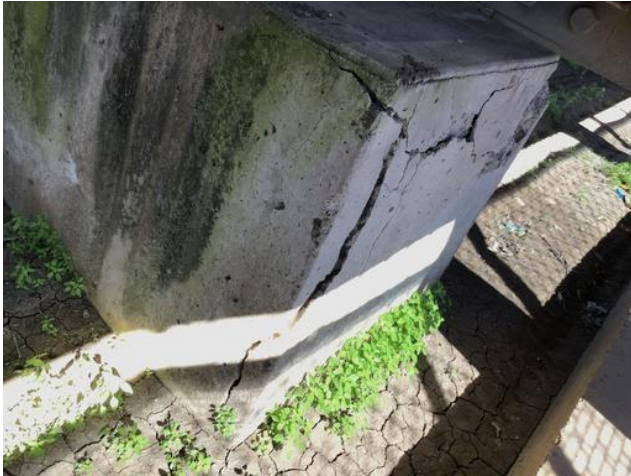
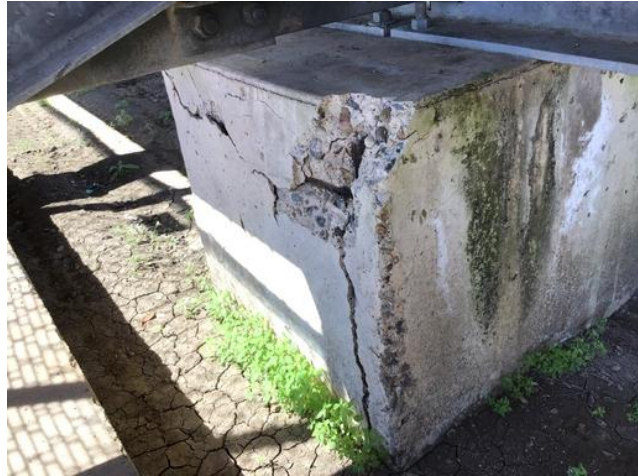
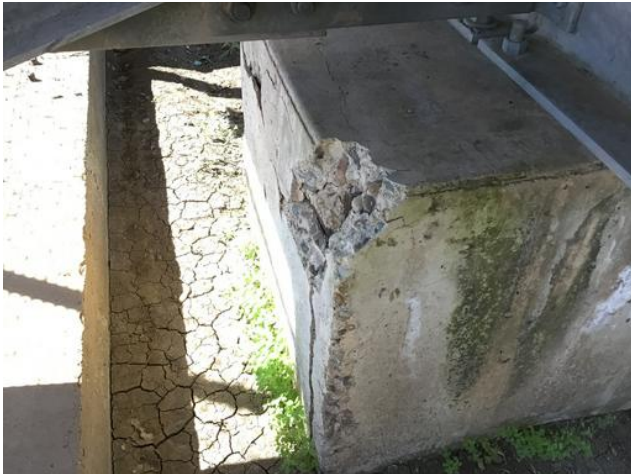
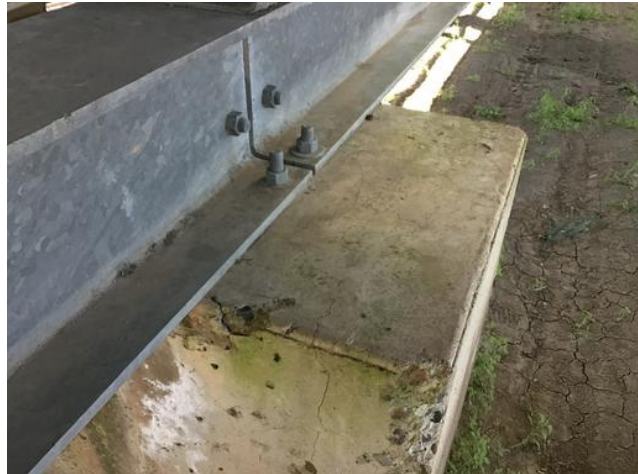
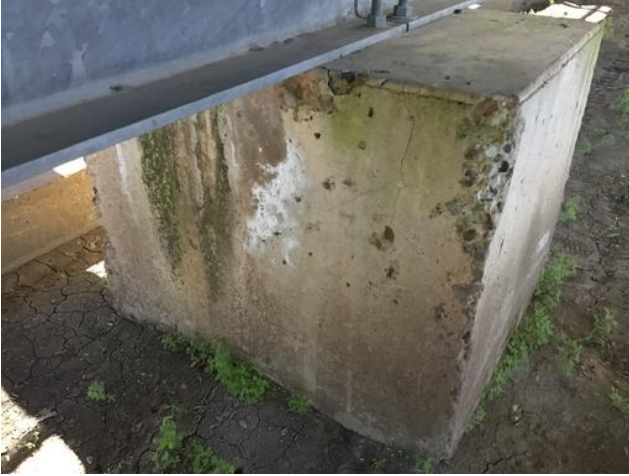
## #41 Spalled Concrete Pedastal

Damage

Design >  
Design and/or construction  
deficiency

Concrete pedestal, shear  
failure and lack of  
confinement of vertical  
reinforcing and anchor bolts.

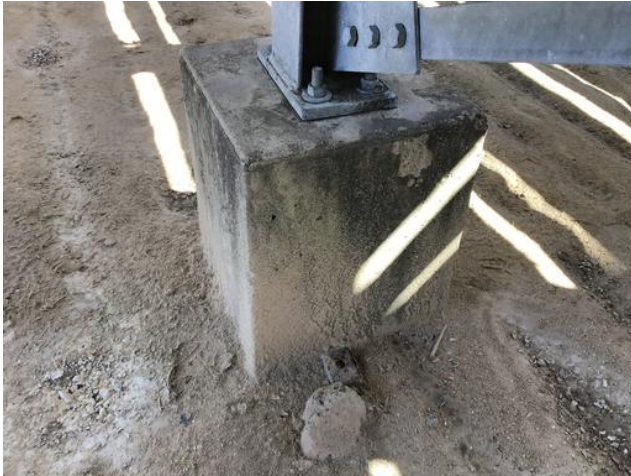
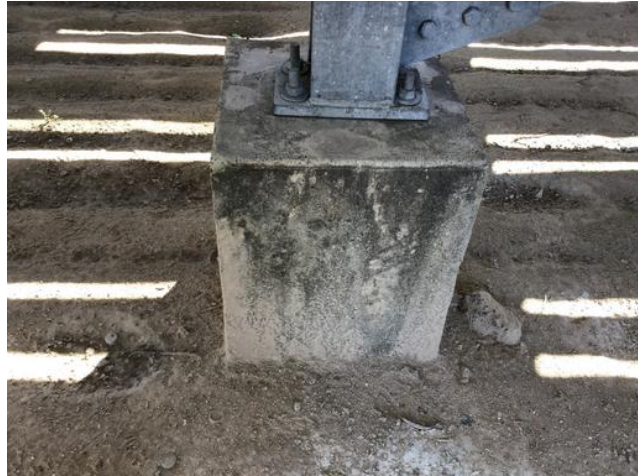
## #40 Spalled Concrete Pedastal

Damage

Design >  
Design and/or construction  
deficiency

Concrete pedestal, shear  
failure and lack of  
confinement of vertical  
reinforcing and anchor bolts.

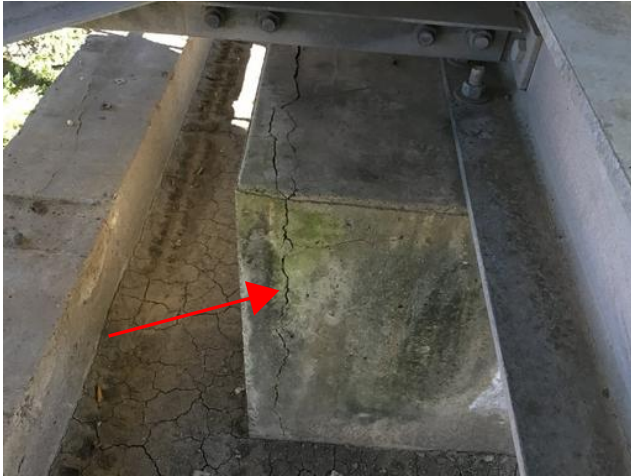
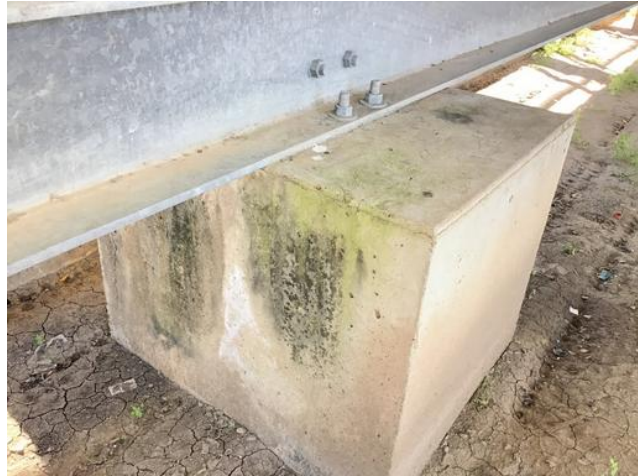
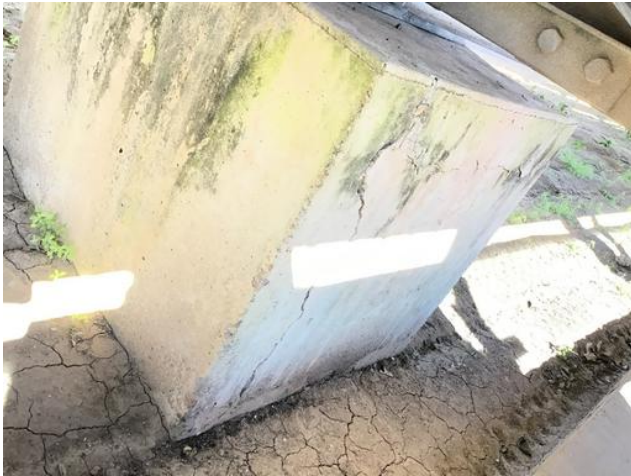
## #39 Spalled Concrete Pedastal

Damage

Design >  
Design and/or construction  
deficiency

Concrete pedestal, shear  
failure and lack of  
confinement of vertical  
reinforcing and anchor bolts.

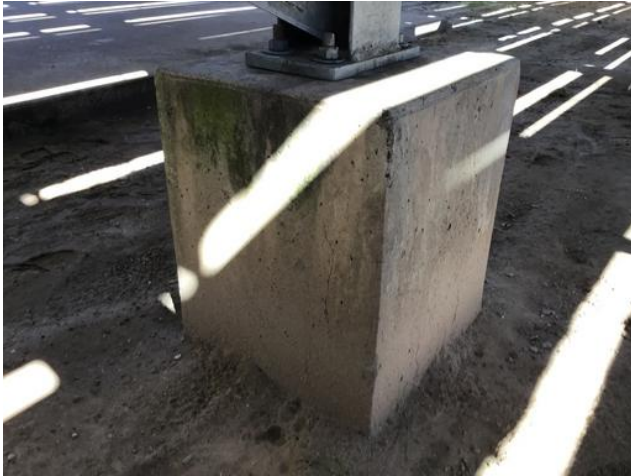
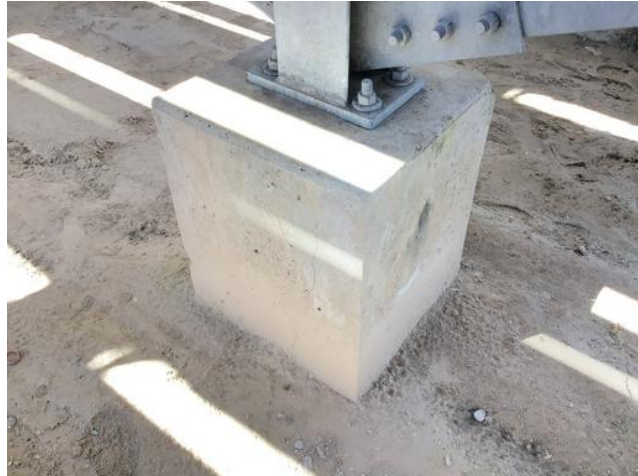
## #38 Spalled Concrete Pedastal

Damage

Design >  
Design and/or construction  
deficiency

Concrete pedestal, shear  
failure and lack of  
confinement of vertical  
reinforcing and anchor bolts.

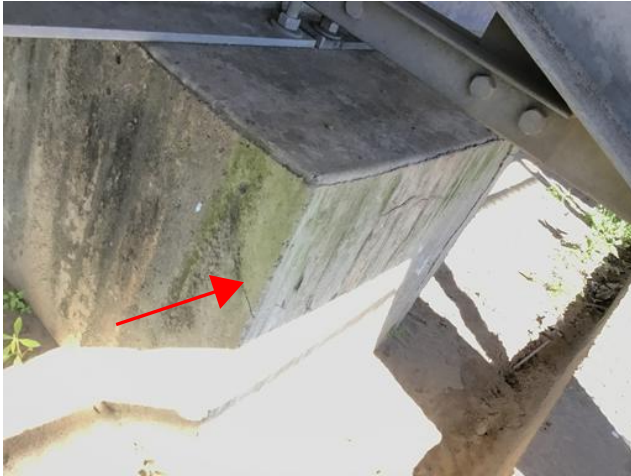
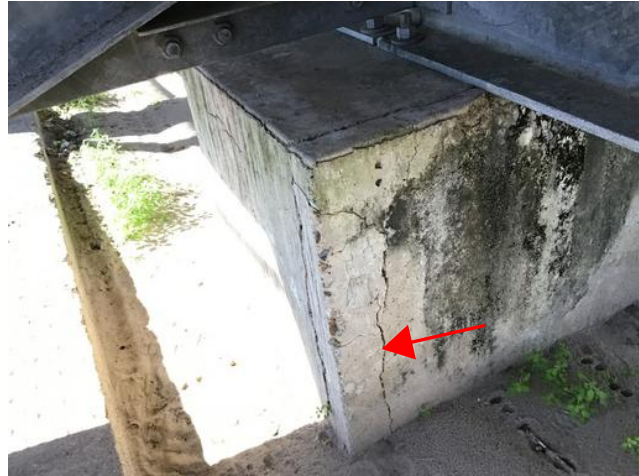
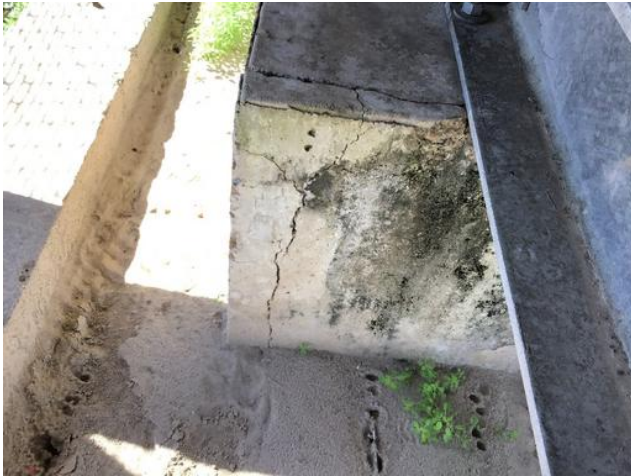
## #37 Spalled Concrete Pedastal

Damage

Design >  
Design and/or construction  
deficiency

Concrete pedestal, shear  
failure and lack of  
confinement of vertical  
reinforcing and anchor bolts.

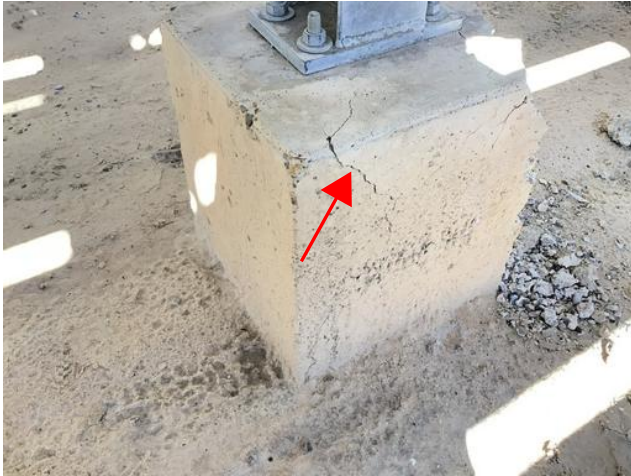
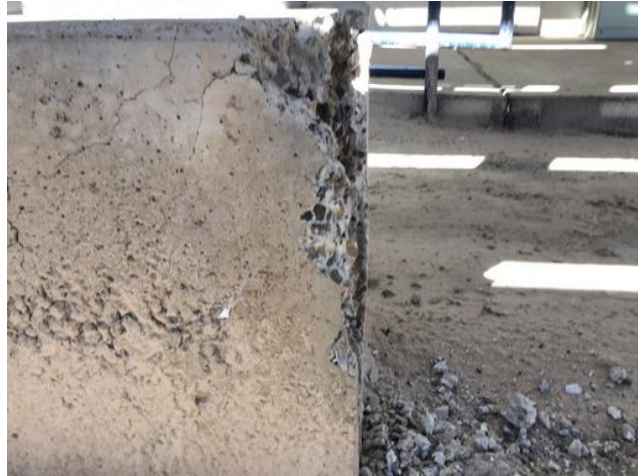
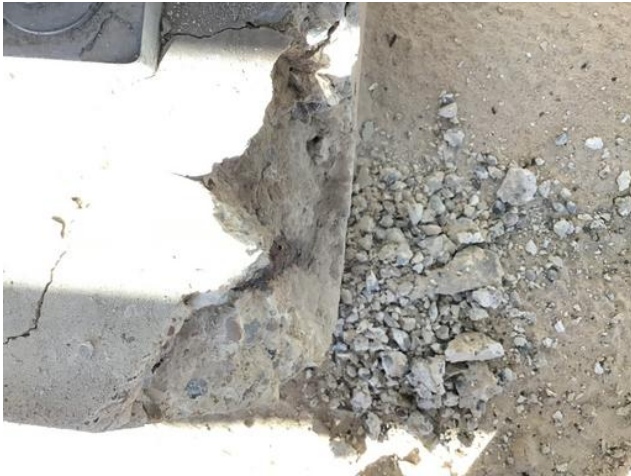
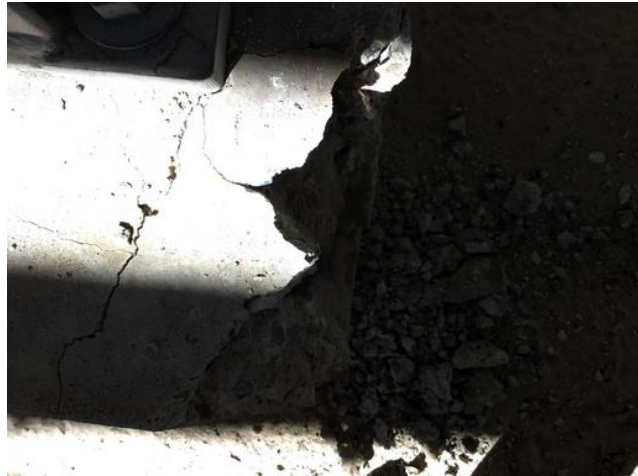
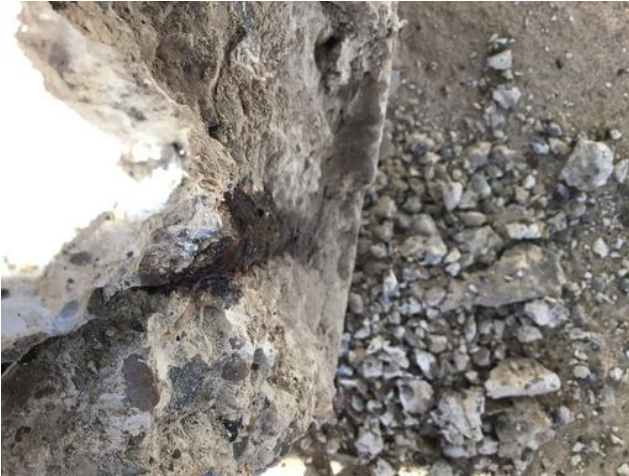
## #36 Spalled Concrete Pedastal

Damage

Design >  
Design and/or construction  
deficiency

Concrete pedestal, shear  
failure and lack of  
confinement of vertical  
reinforcing and anchor bolts.

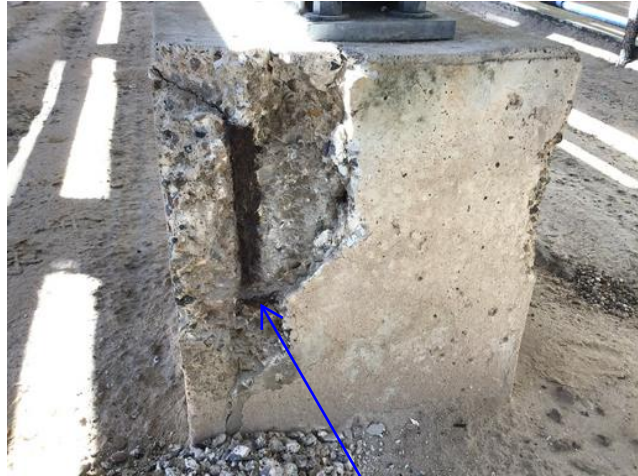
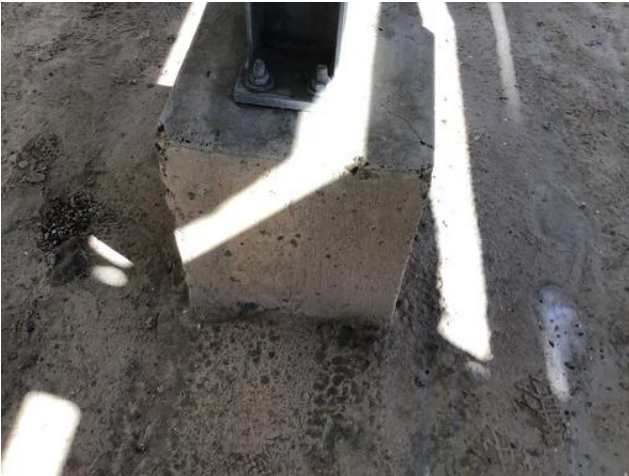
#3 tie.  
No tie at the top of the pier and spacing is inadequate to confine the anchor bolts for shear

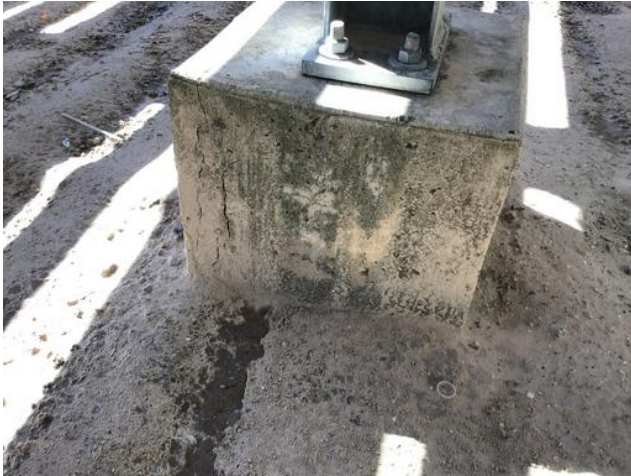
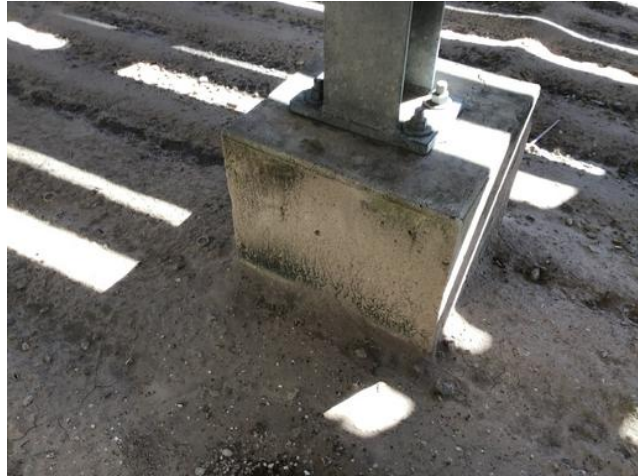
## #35 Spalled Concrete Pedastal

Damage

Design >  
Design and/or construction  
deficiency

Concrete pedestal, shear  
failure and lack of  
confinement of vertical  
reinforcing and anchor bolts.

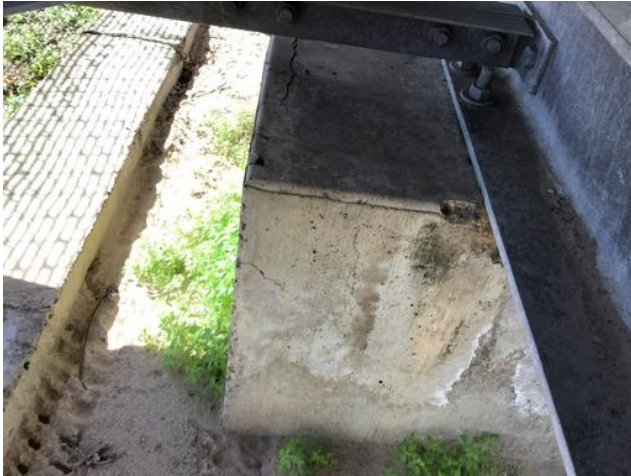
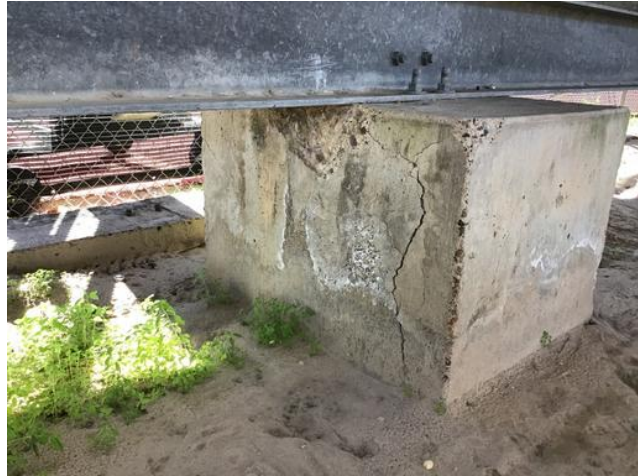
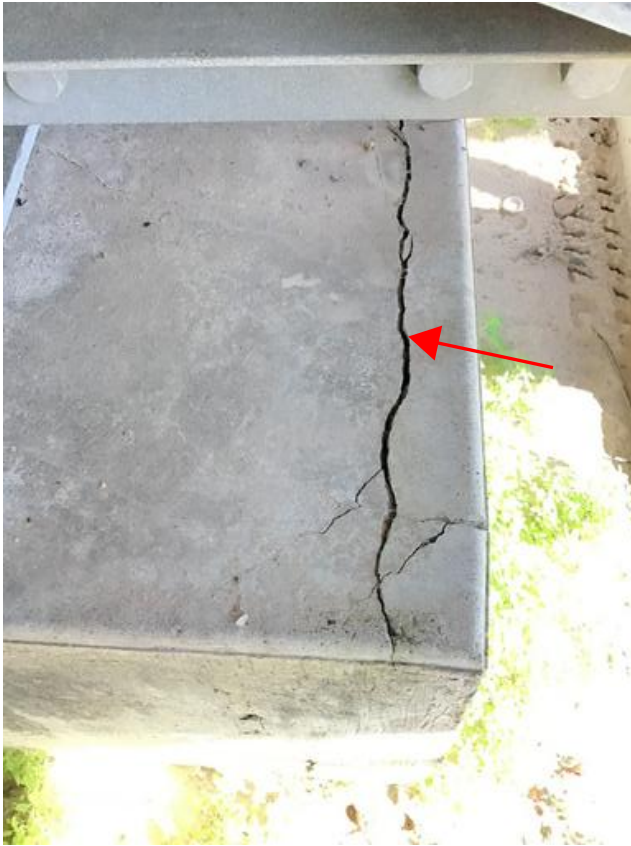
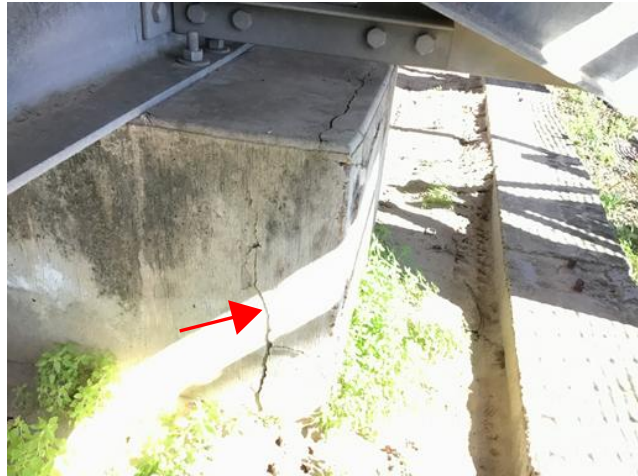
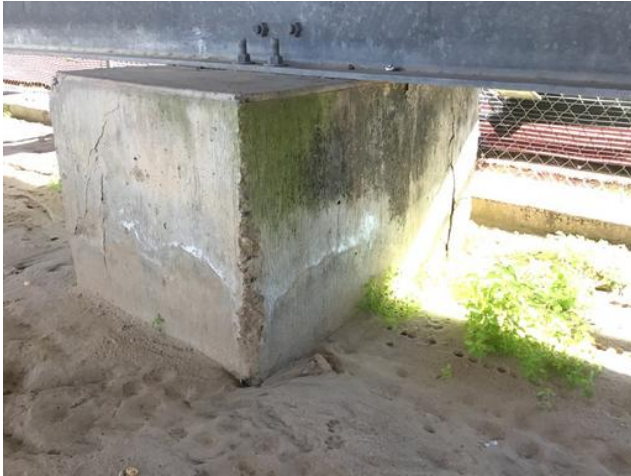
## #34 Spalled Concrete Pedastal

Damage

Design >  
Design and/or construction  
deficiency

Concrete pedestal, shear  
failure and lack of  
confinement of vertical  
reinforcing and anchor bolts.

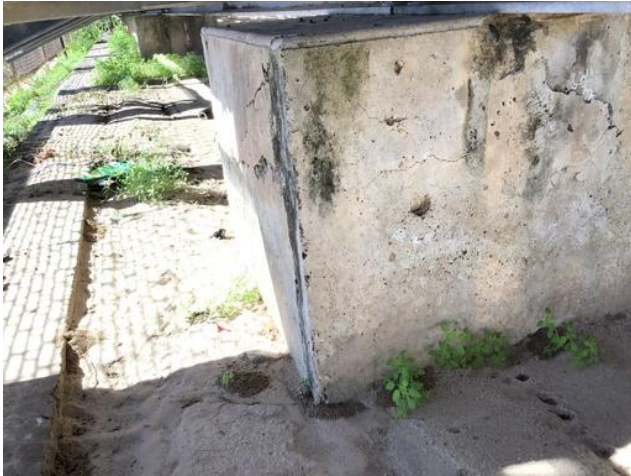
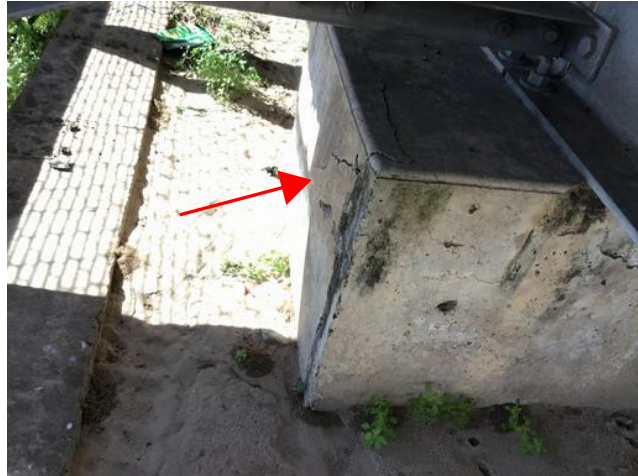
## #33 Spalled Concrete Pedastal

Damage

Concrete pedestal, shear  
failure and lack of  
confinement of vertical  
reinforcing and anchor bolts.

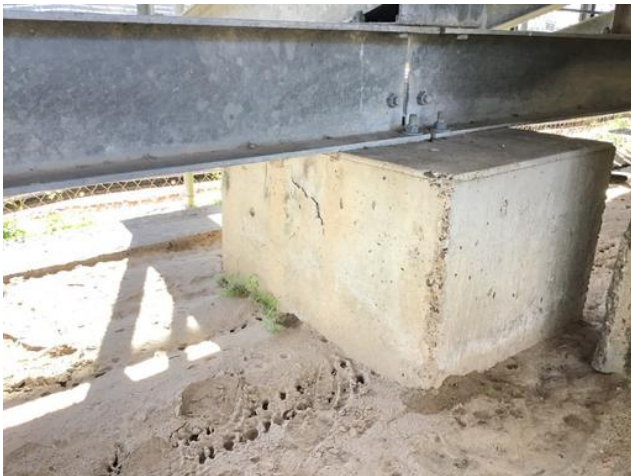
Design >  
Design and/or construction  
deficiency

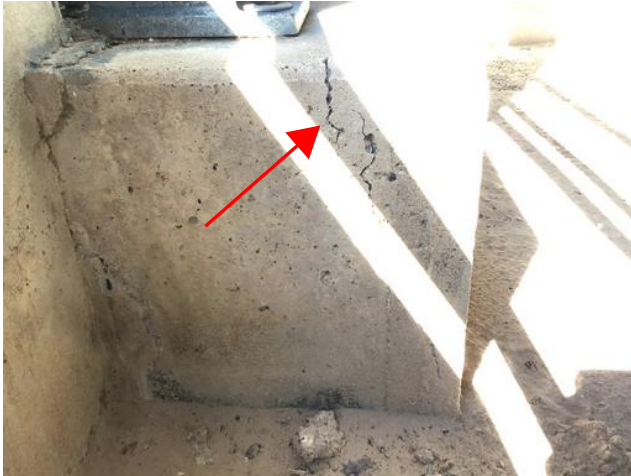
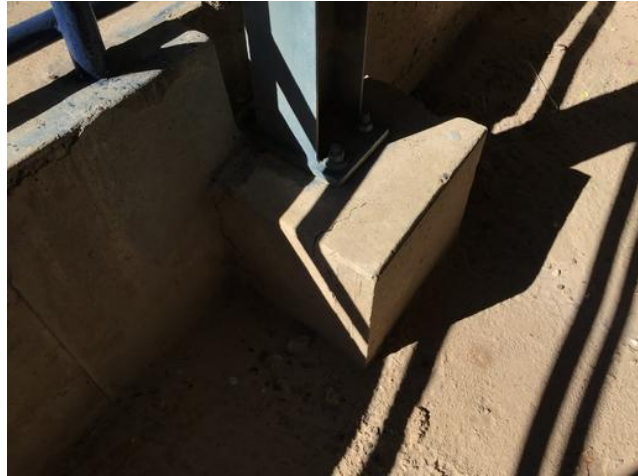
## #32 Spalled Concrete Pedestal

Damage

Concrete pedestal, shear  
failure and lack of  
confinement of vertical  
reinforcing and anchor bolts.

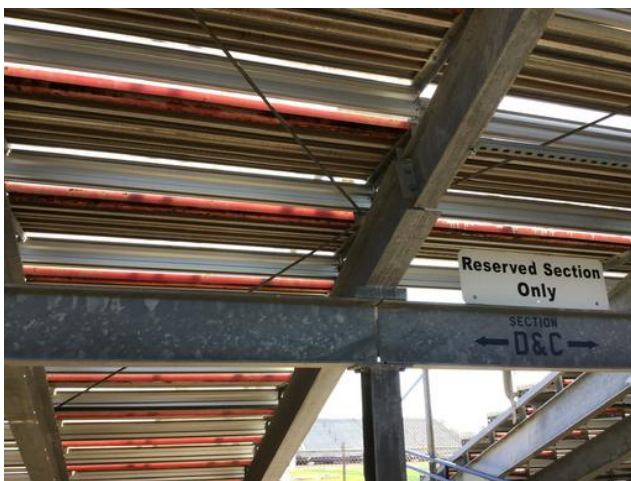
## #31 Aluminum Footer

12 Footer used is not  
aluminum and has corroded

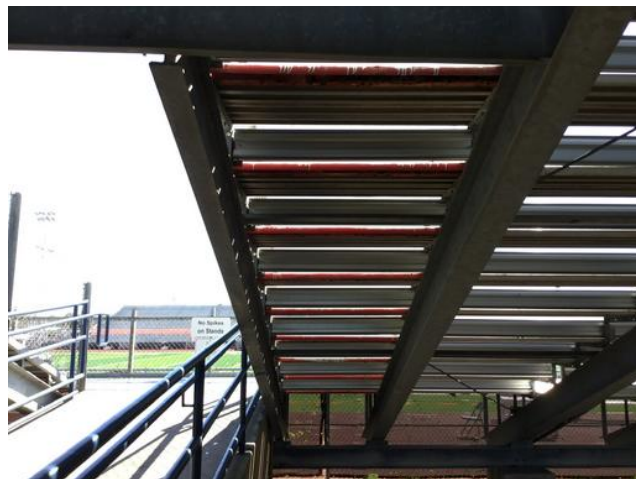
Design >  
Improper use of material  
type

11 Footer used is not  
aluminum and has corroded

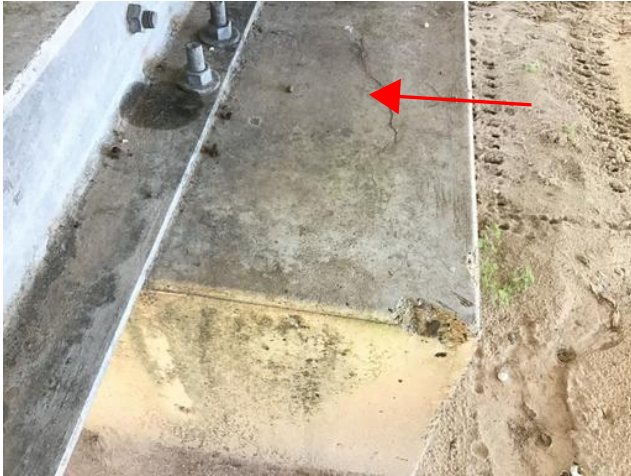
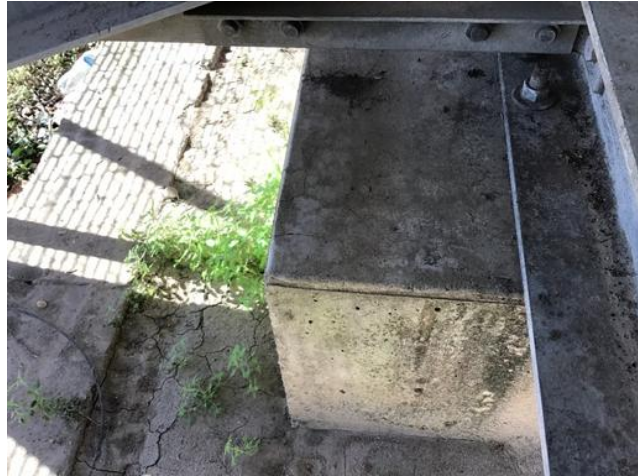
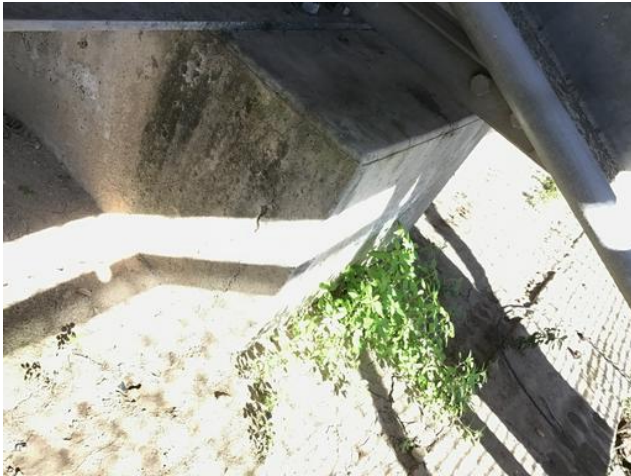
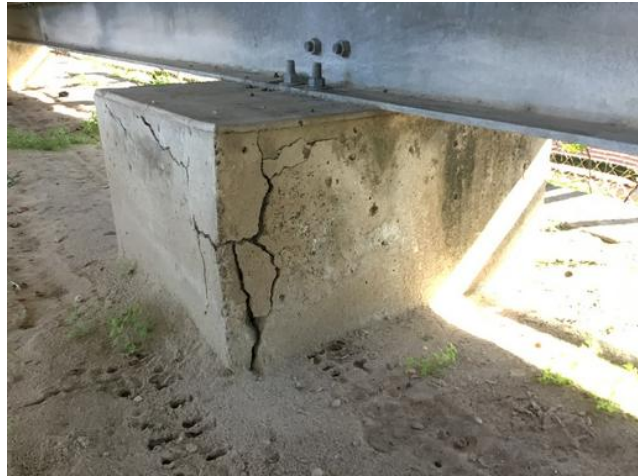
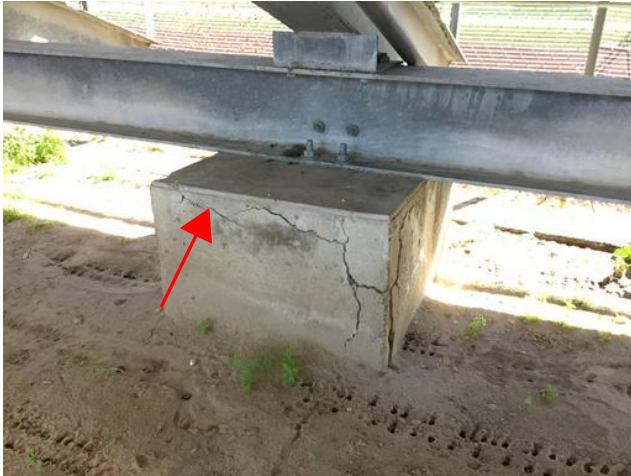
## #29 Spalled Concrete Pedastal

Damage

Concrete pedestal, shear  
failure and lack of  
confinement of vertical  
reinforcing and anchor bolts.

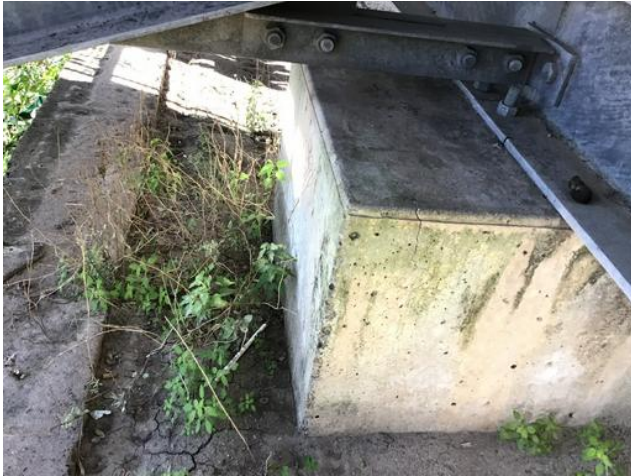
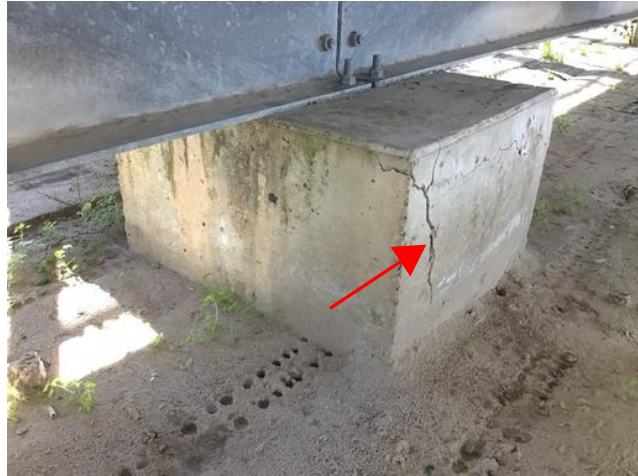
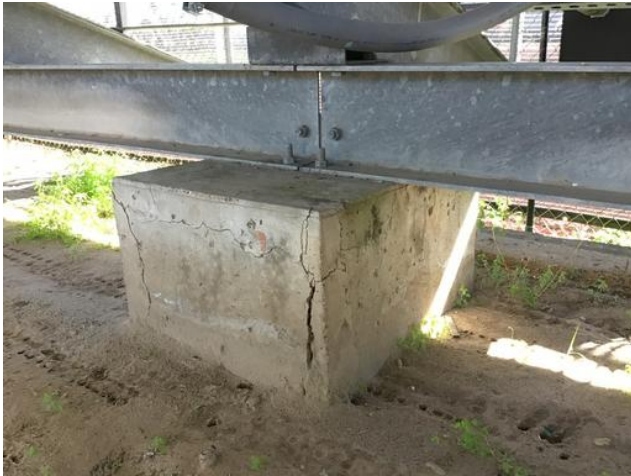
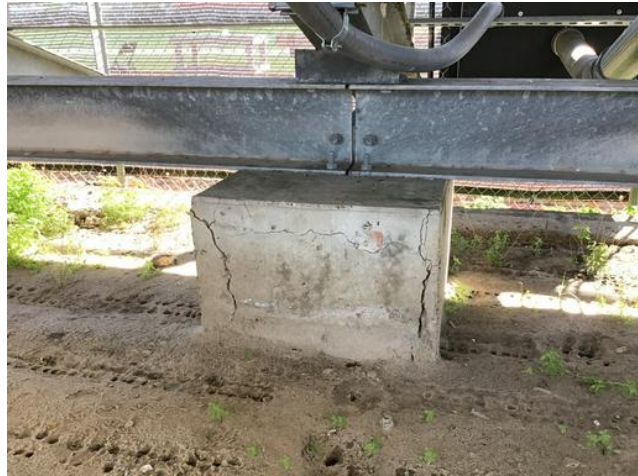
## #28 Spalled Concrete Pedestal

Damage

Concrete pedestal, shear  
failure and lack of  
confinement of vertical  
reinforcing and anchor bolts.

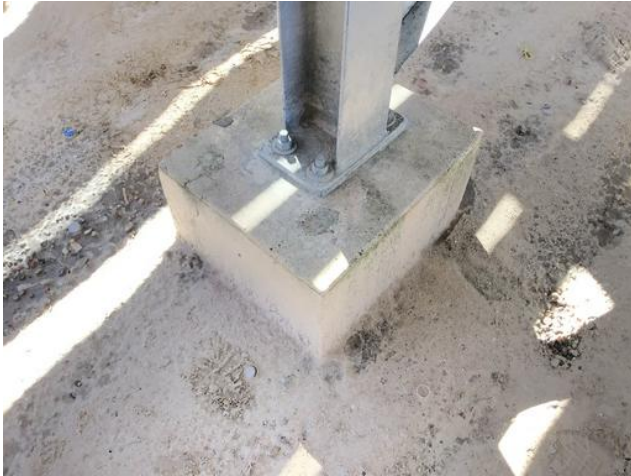
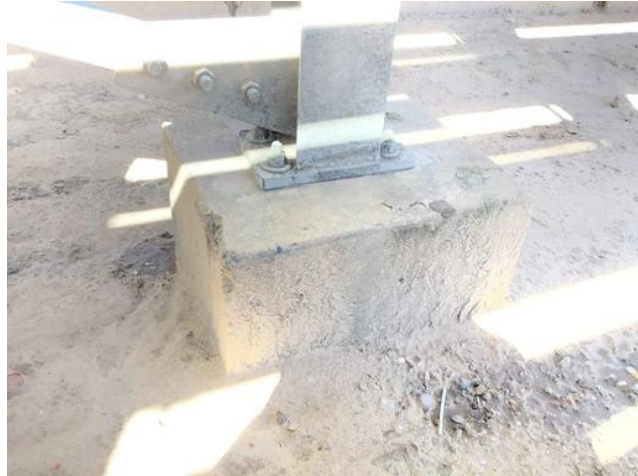
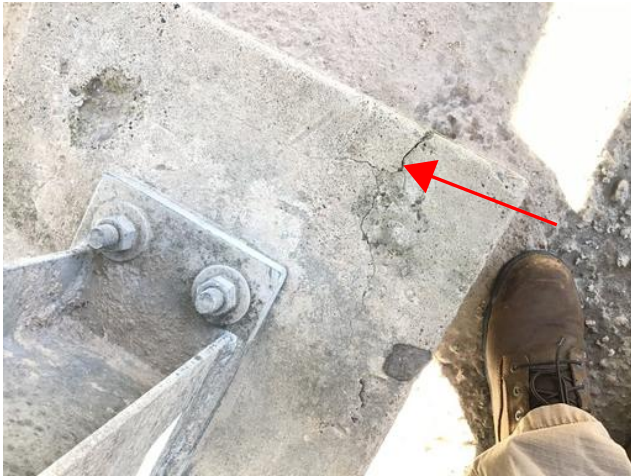
## #27 Spalled Concrete Pedastal

Damage

Concrete pedestal, shear  
failure and lack of  
confinement of vertical  
reinforcing and anchor bolts.

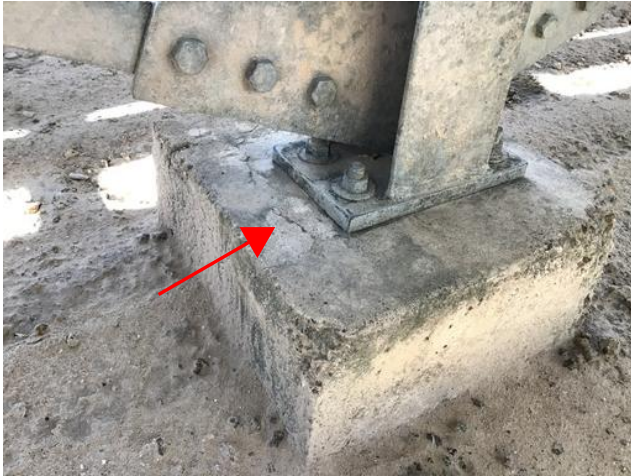
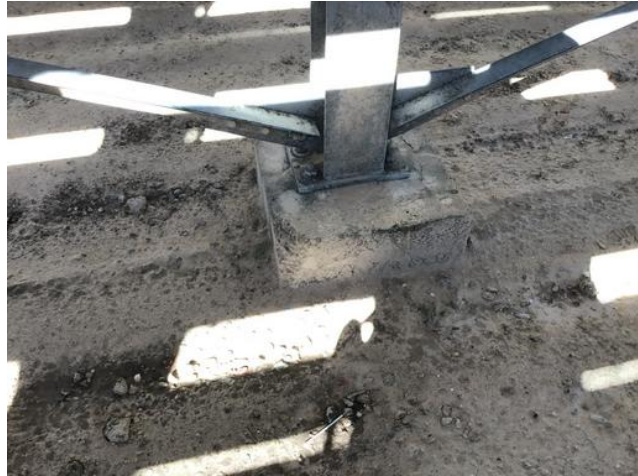
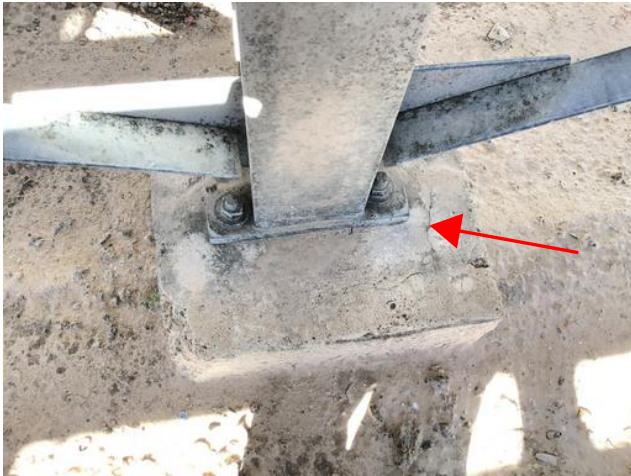
## #26 Spalled Concrete Pedastal

Damage

Concrete pedestal, shear  
failure and lack of  
confinement of vertical  
reinforcing and anchor bolts.

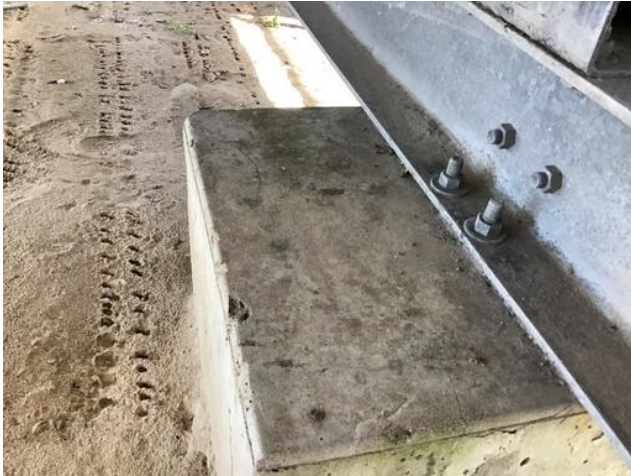
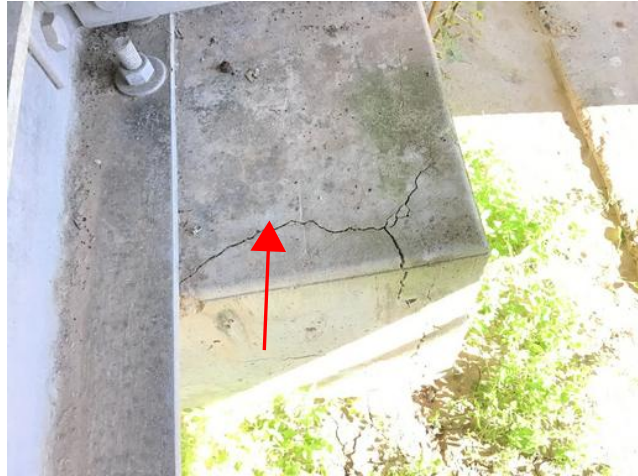
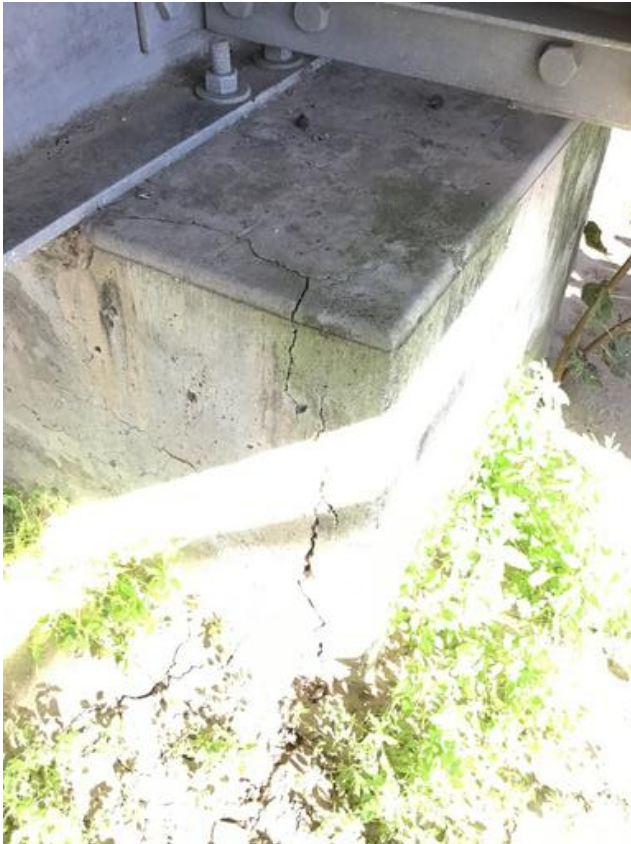
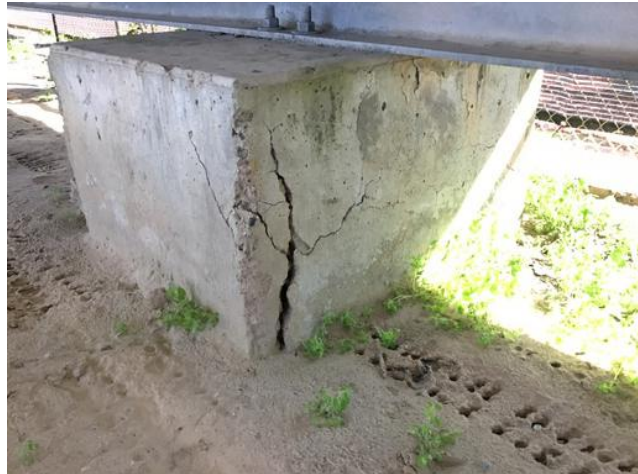
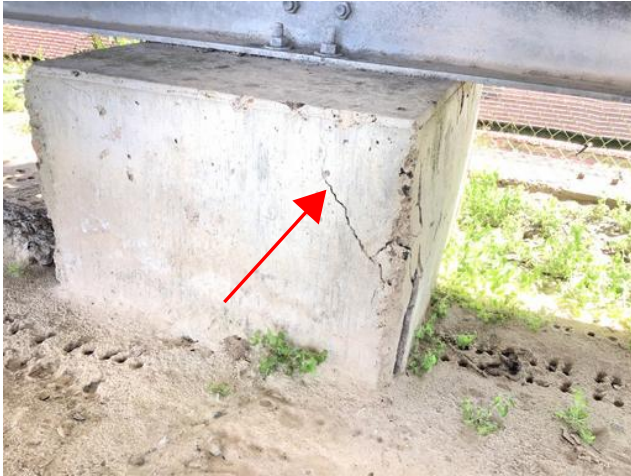
## #25 Spalled Concrete Pedastal

Damage

Concrete pedestal, shear  
failure and lack of  
confinement of vertical  
reinforcing and anchor bolts.

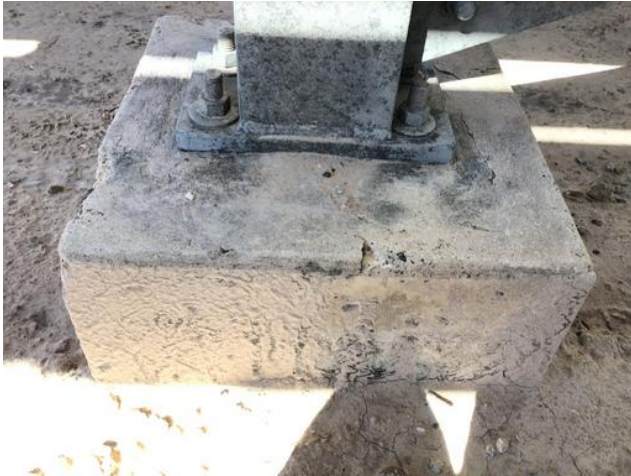
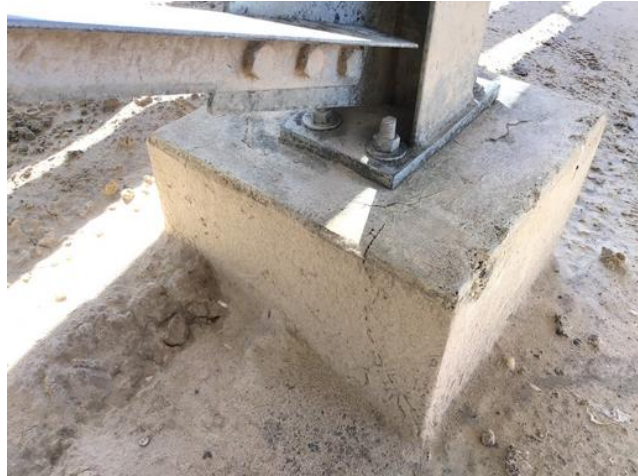
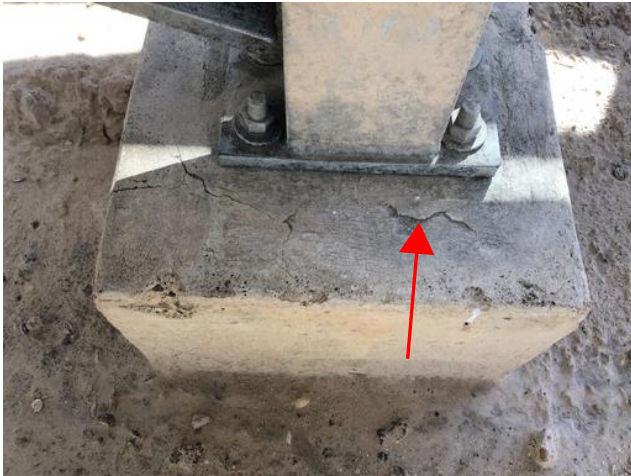
## #24 Spalled Concrete Pedastal

Damage

Concrete pedestal, shear  
failure and lack of  
confinement of vertical  
reinforcing and anchor bolts.

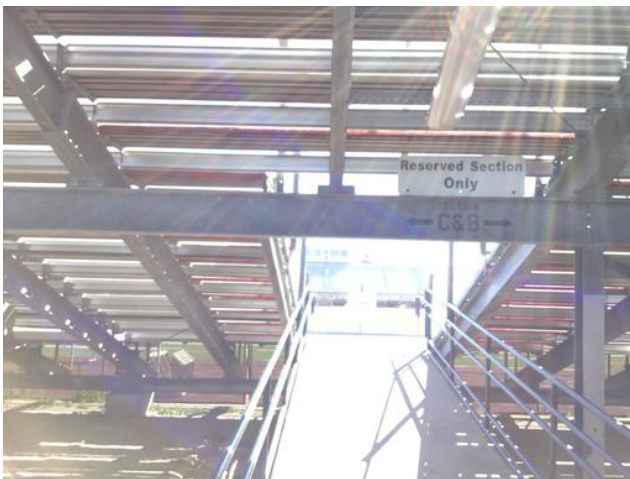
## #23 Aluminum Footer

13 Footer used is not  
aluminum and has corroded
