# ECISD Richard R. Flores Structural Repair - Mar 1, 2022

Prepared by Simon Solorio

Mar 7, 2022

Field observations.

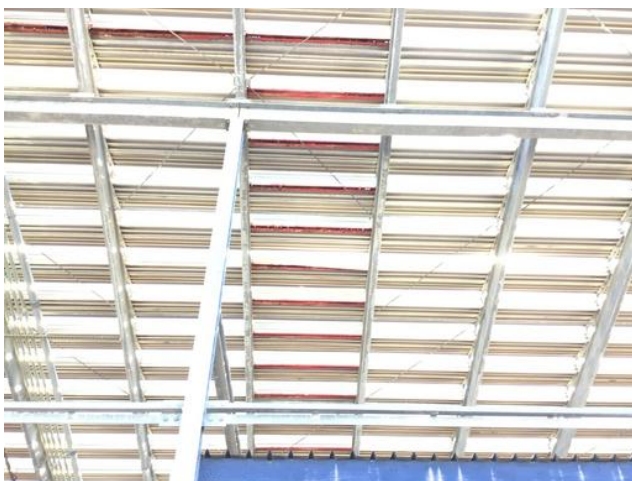
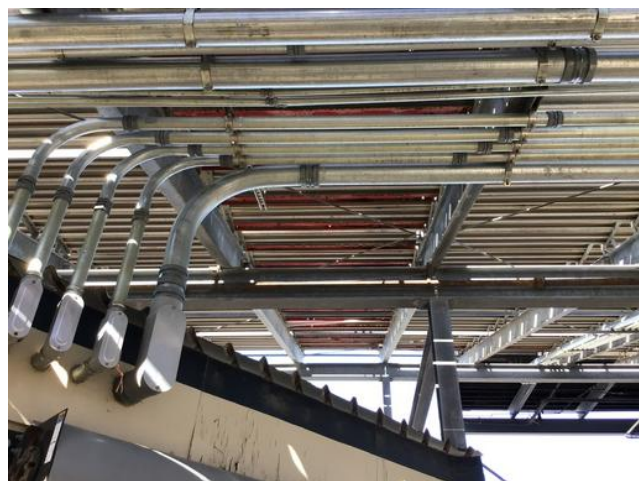
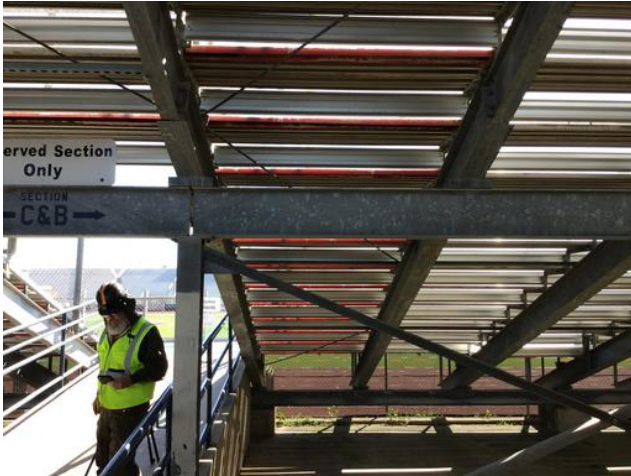
34 Footer used is not  
aluminum and has corroded

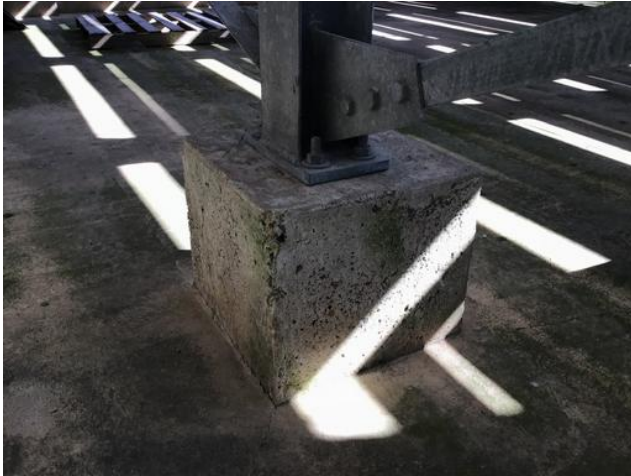
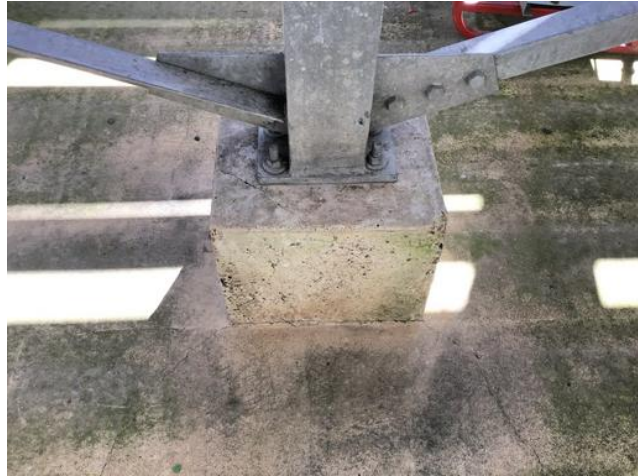
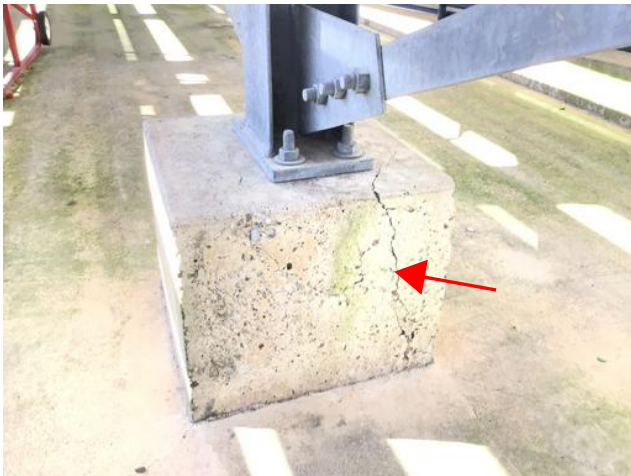
## #20 Spalled Concrete Pedestal

Damage

Concrete pedestal, shear  
failure and lack of  
confinement of vertical  
reinforcing and anchor bolts.

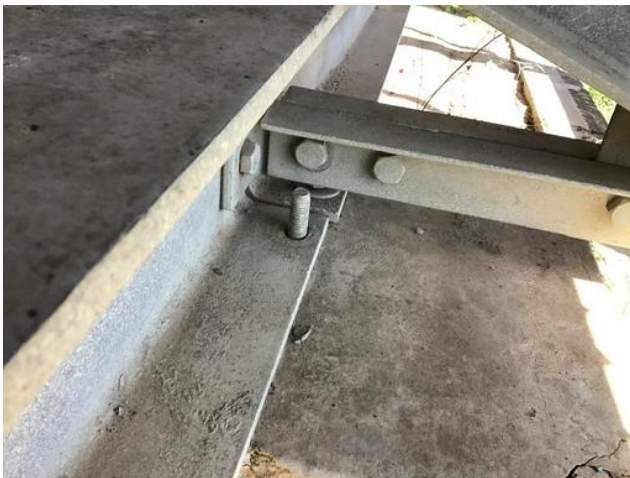
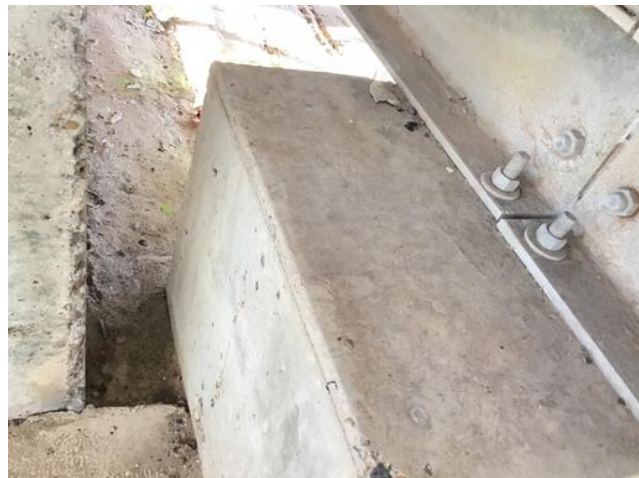
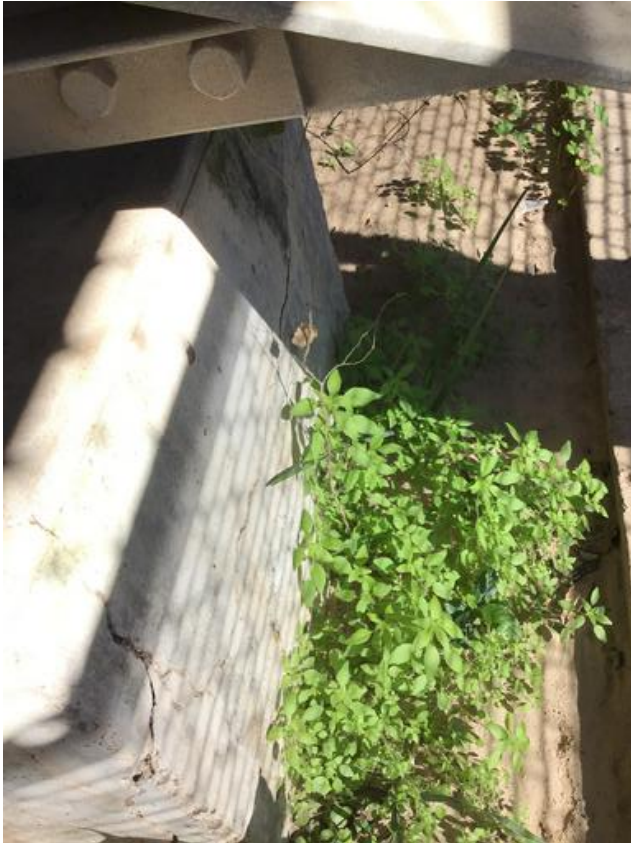
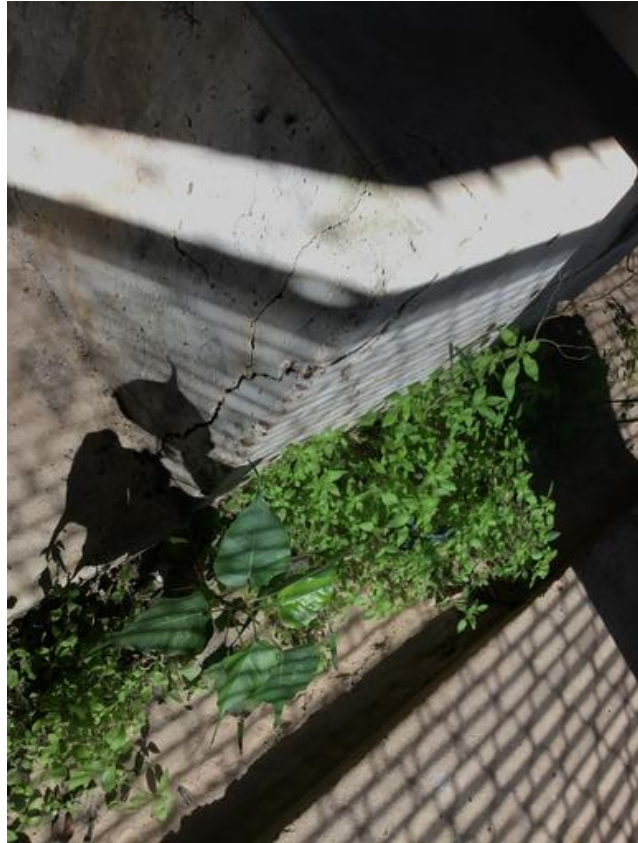
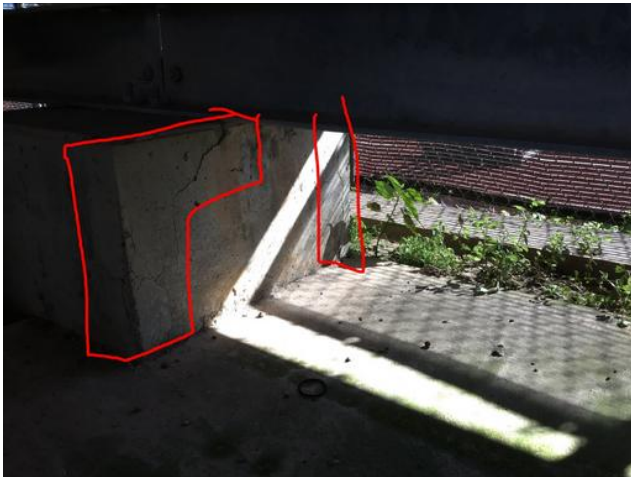
## #19 Spalled Concrete Pedestal

Concrete pedestal, shear  
failure and lack of  
confinement of vertical  
reinforcing and anchor bolts.

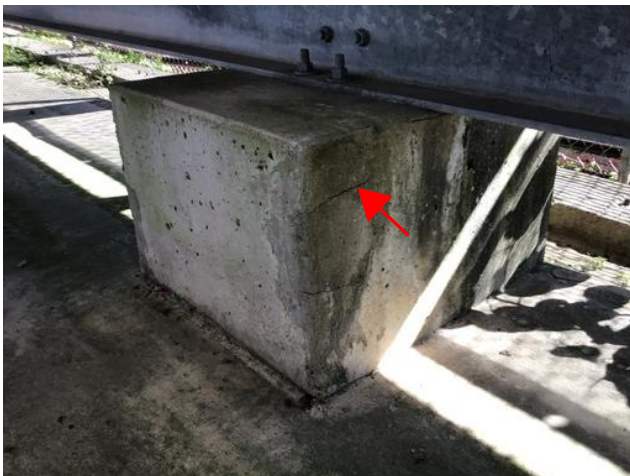
20220301\_095053\_photo

Design >  
Design and/or construction  
deficiency

Concrete pedestal, shear  
failure and lack of  
confinement of vertical  
reinforcing and anchor bolts.

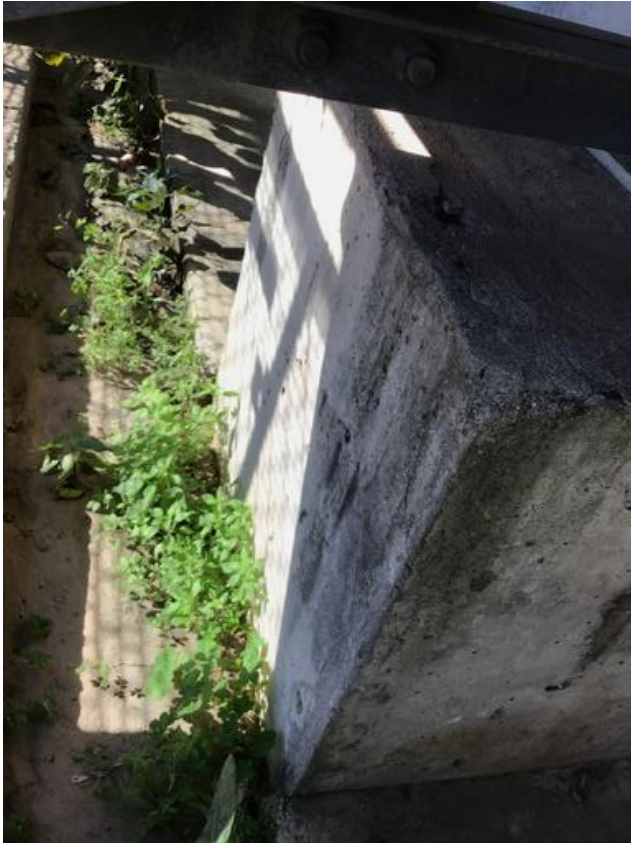
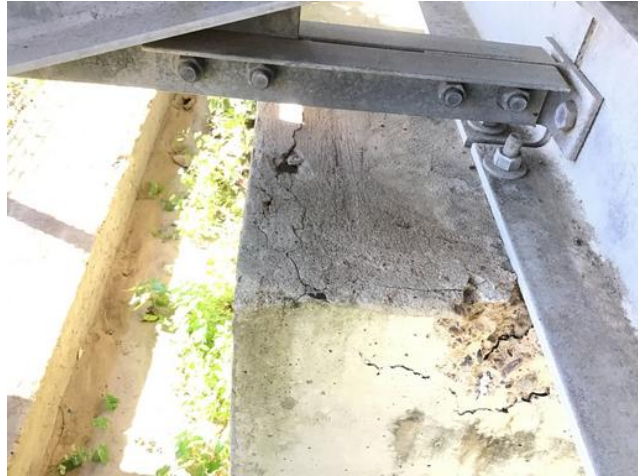
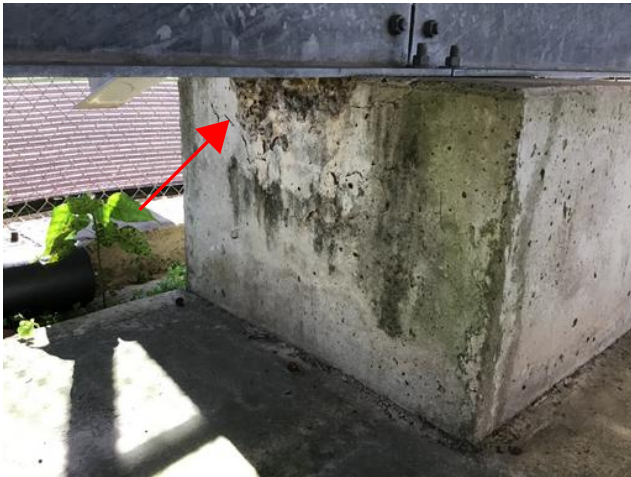
Design >  
Design and/or construction  
deficiency

Concrete pedestal, shear  
failure and lack of  
confinement of vertical  
reinforcing and anchor bolts.

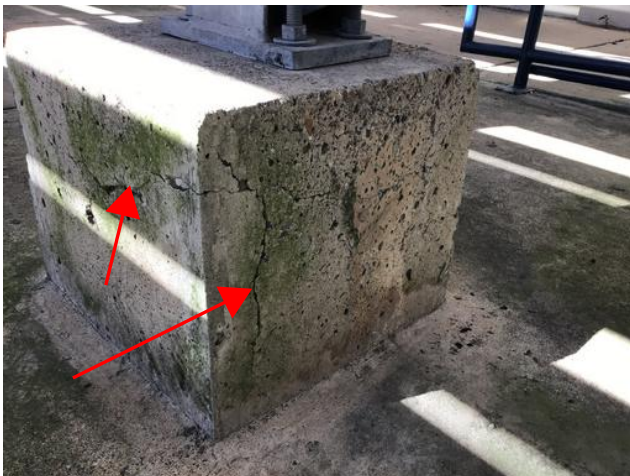
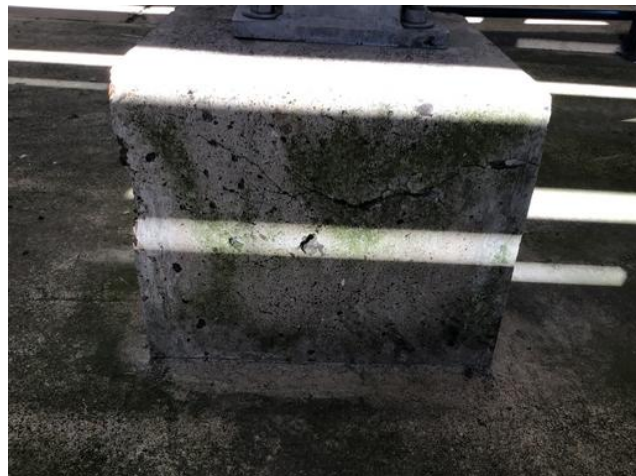
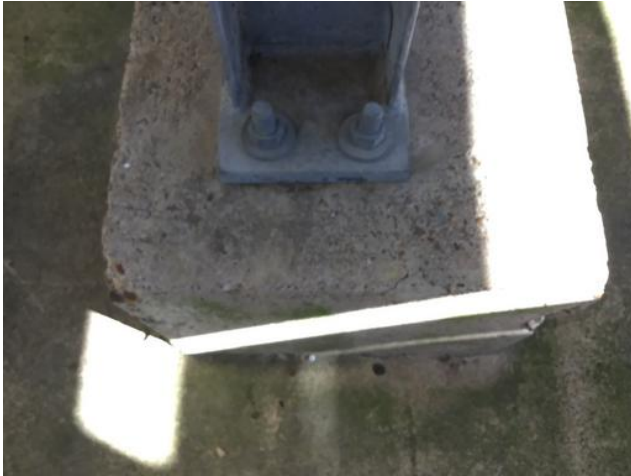
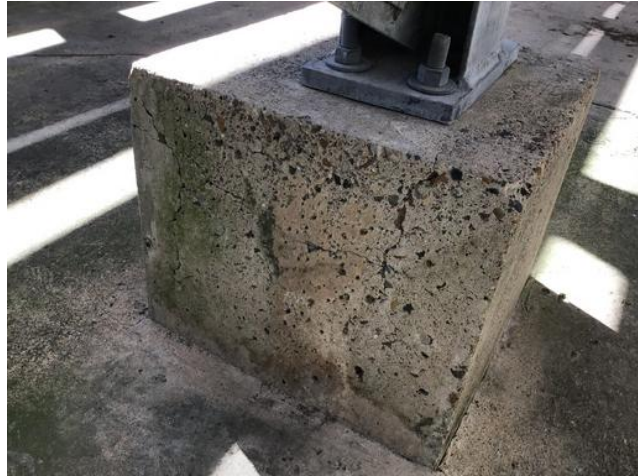
Design >  
Design and/or construction  
deficiency

Concrete pedestal, shear  
failure and lack of  
confinement of vertical  
reinforcing and anchor bolts.

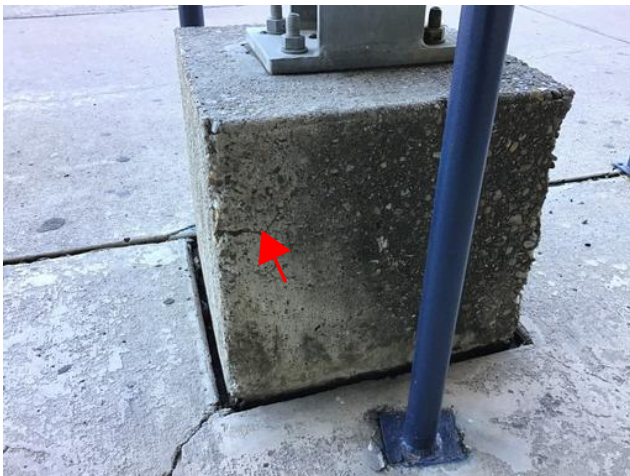
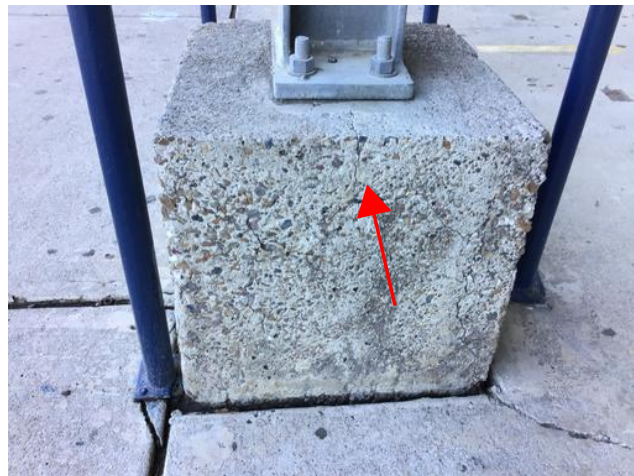
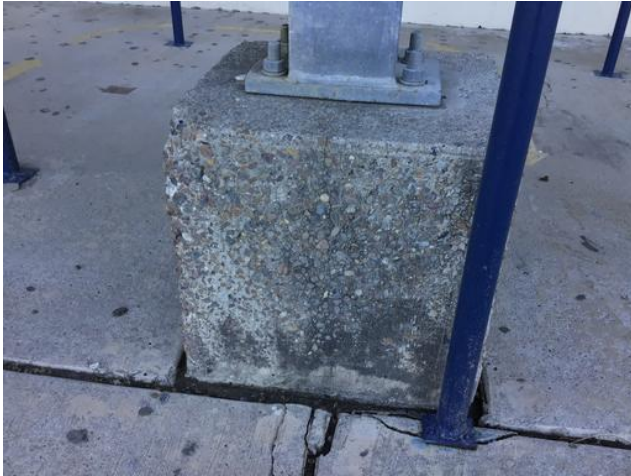
Design >  
Design and/or construction  
deficiency

Concrete pedestal, shear  
failure and lack of  
confinement of vertical  
reinforcing and anchor bolts.

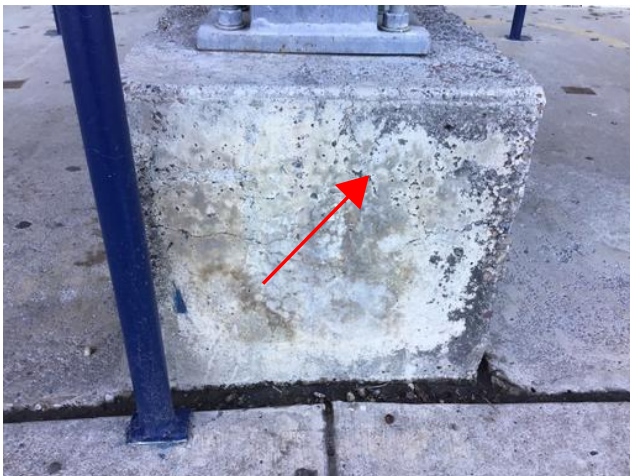
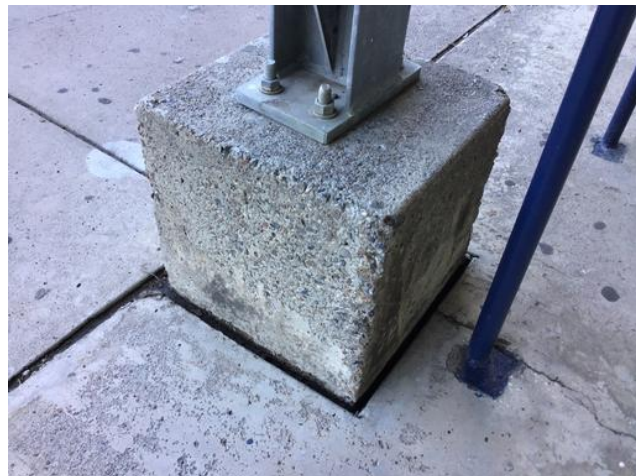
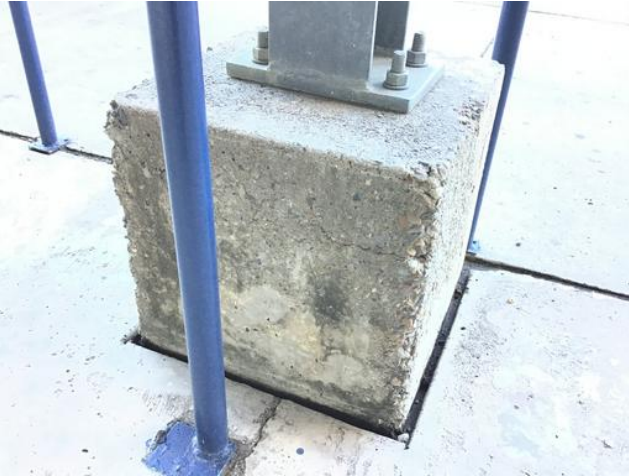
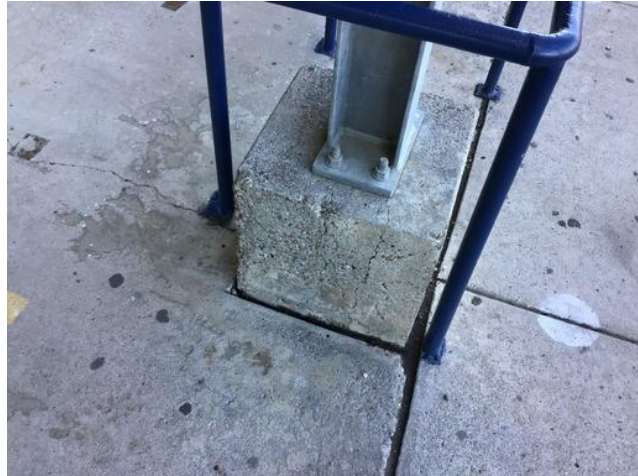
Design >  
Design and/or construction  
deficiency

Concrete pedestal, shear  
failure and lack of  
confinement of vertical  
reinforcing and anchor bolts.

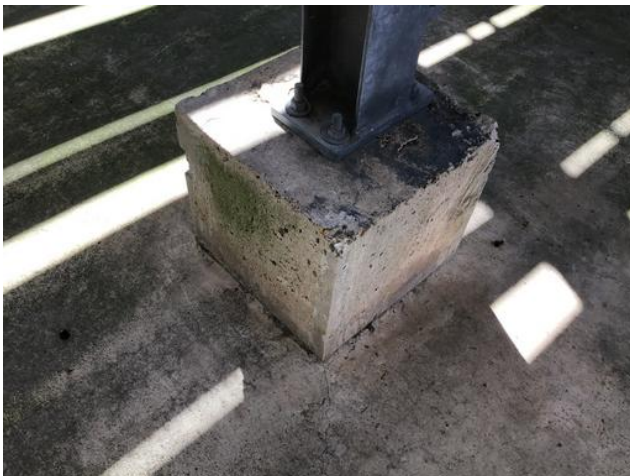
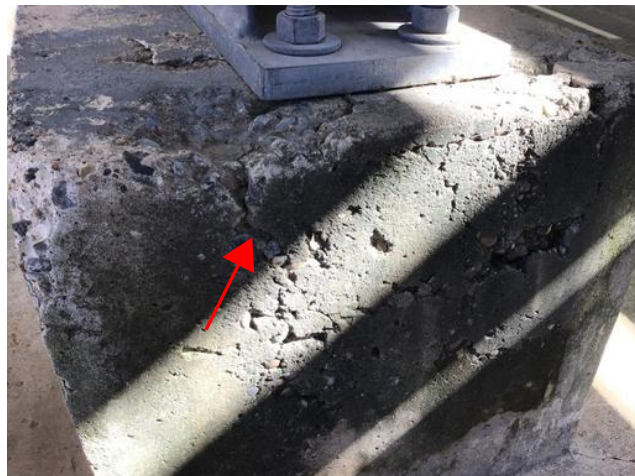
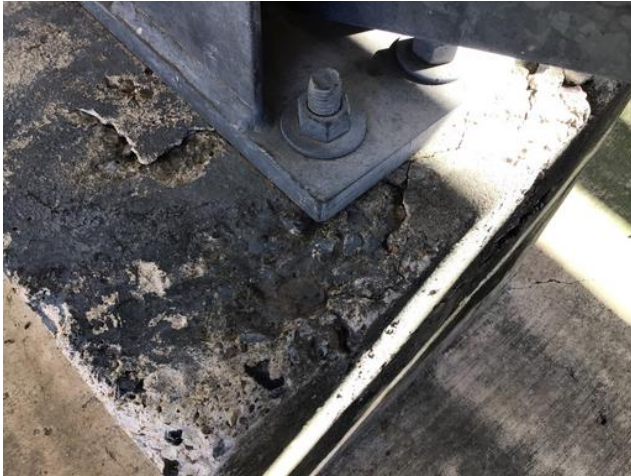
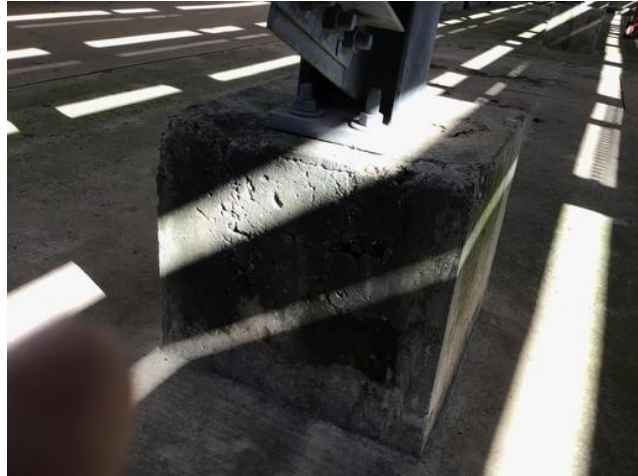
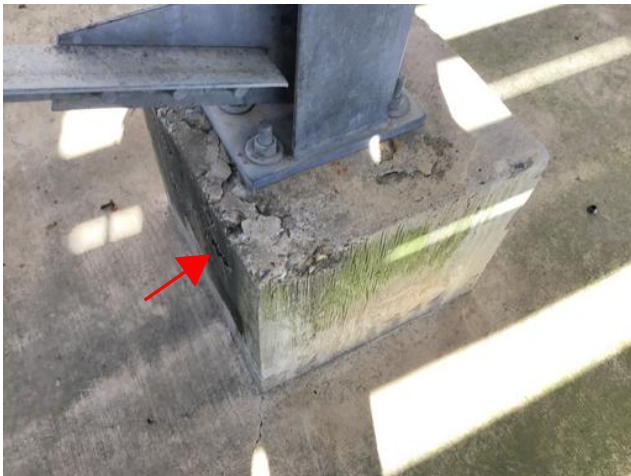
Design >  
Design and/or construction  
deficiency

Concrete pedestal, shear  
failure and lack of  
confinement of vertical  
reinforcing and anchor bolts.

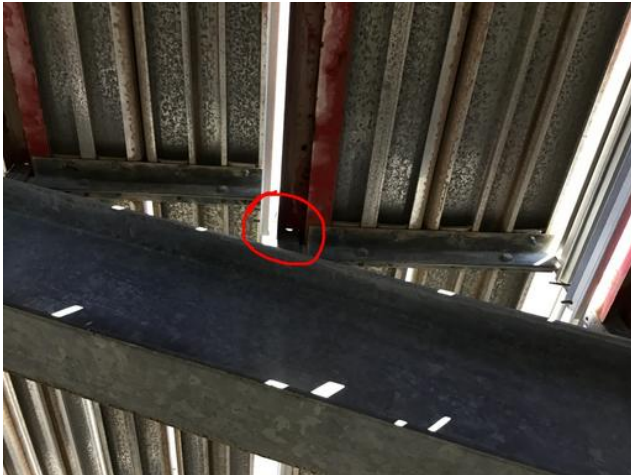
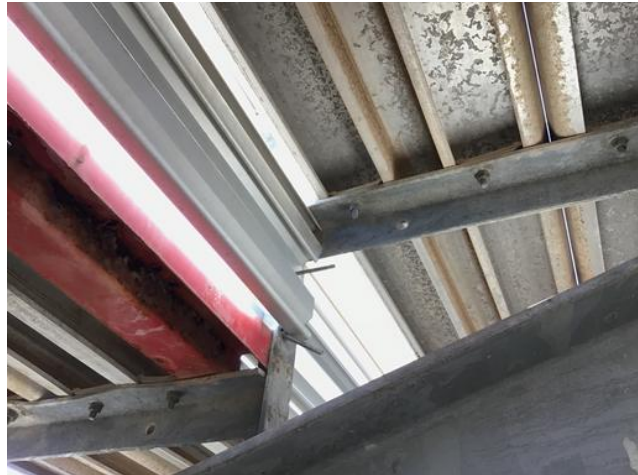
Gap, screw missed

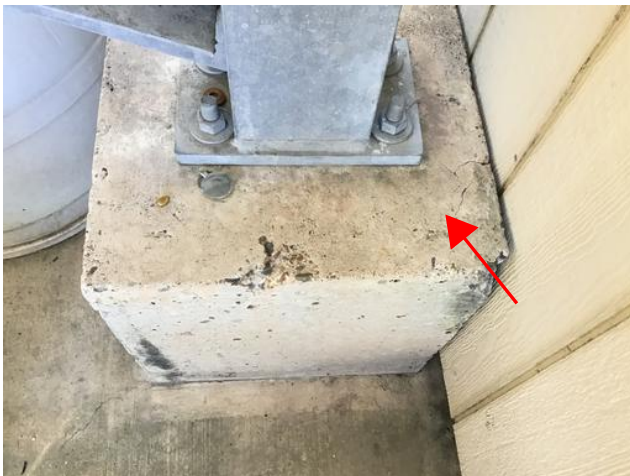
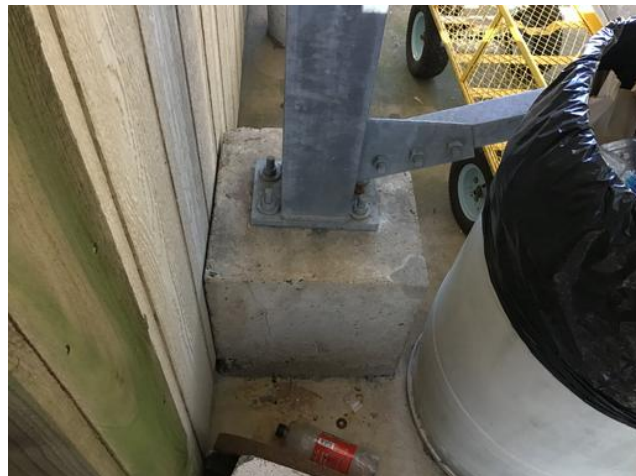
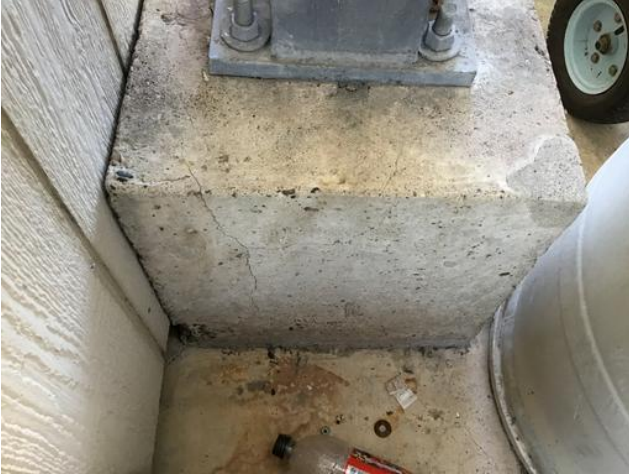
Design >  
Design and/or construction  
deficiency

Concrete pedestal, shear  
failure and lack of  
confinement of vertical  
reinforcing and anchor bolts.

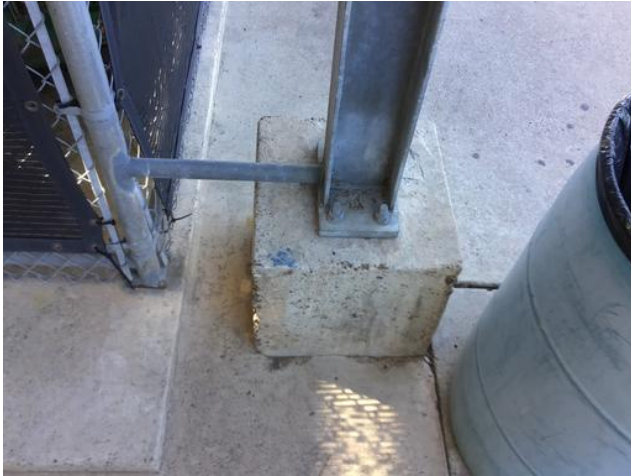
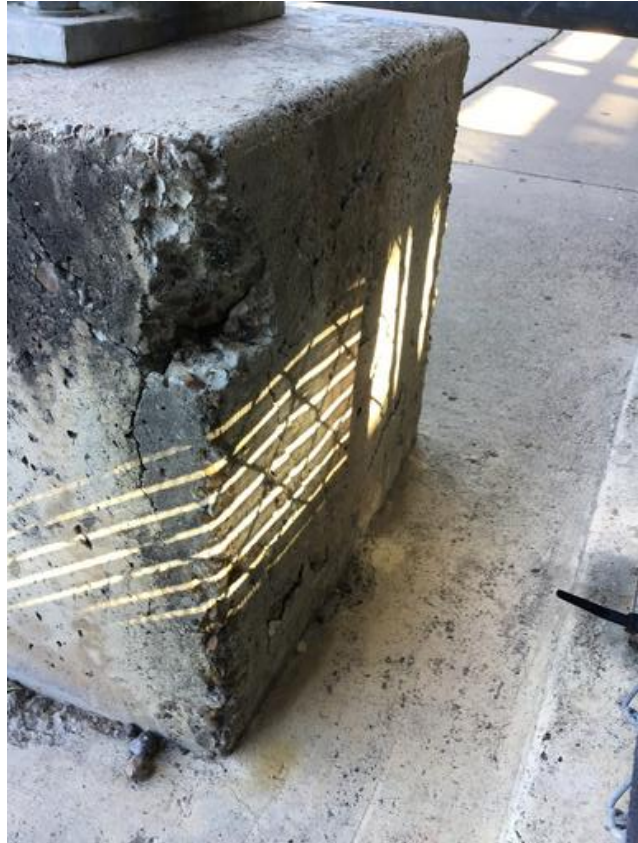
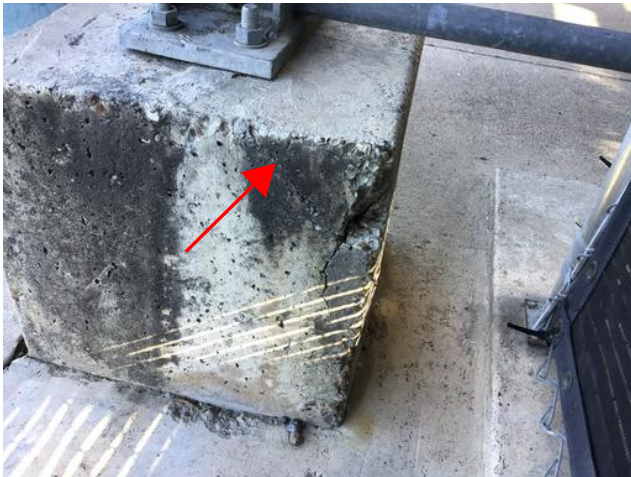
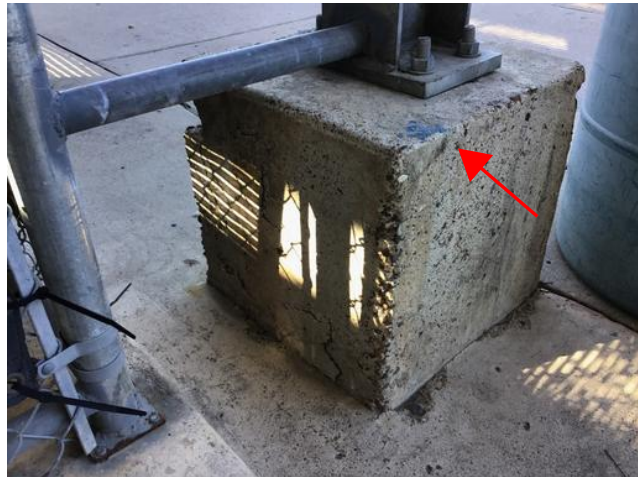
Design >  
Design and/or construction  
deficiency

Concrete pedestal, shear  
failure and lack of  
confinement of vertical  
reinforcing and anchor bolts.

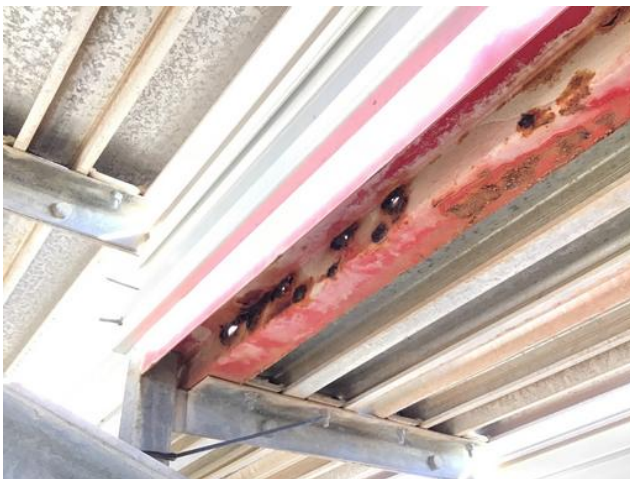
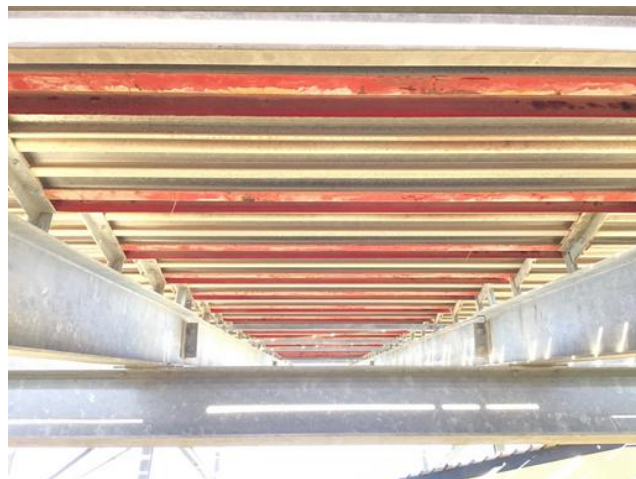
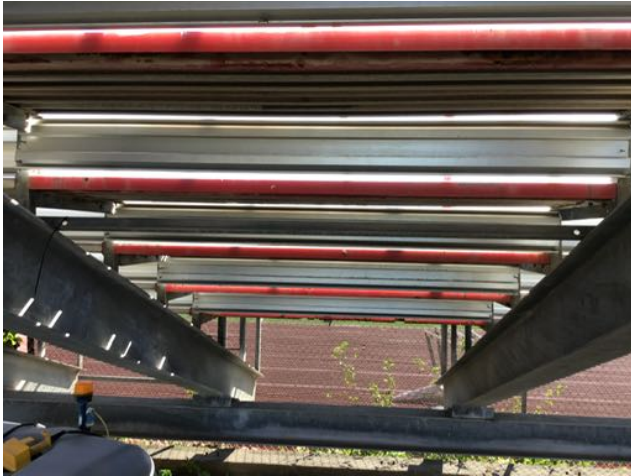
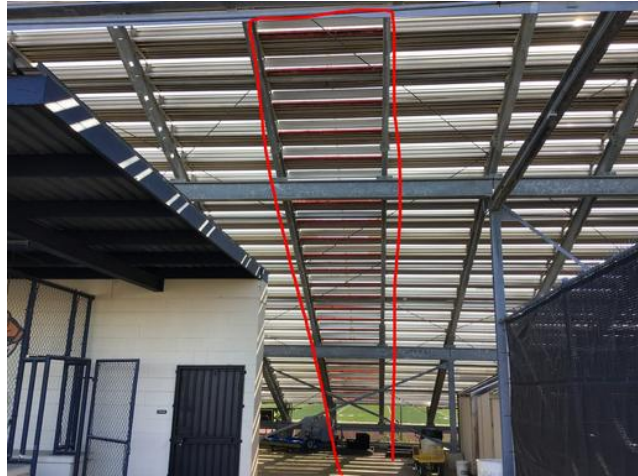
Design >  
Improper use of material  
type

34 Footer used is not  
aluminum and has corroded

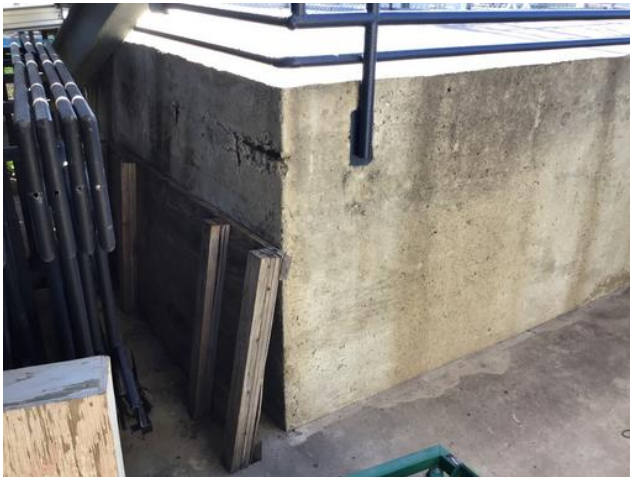
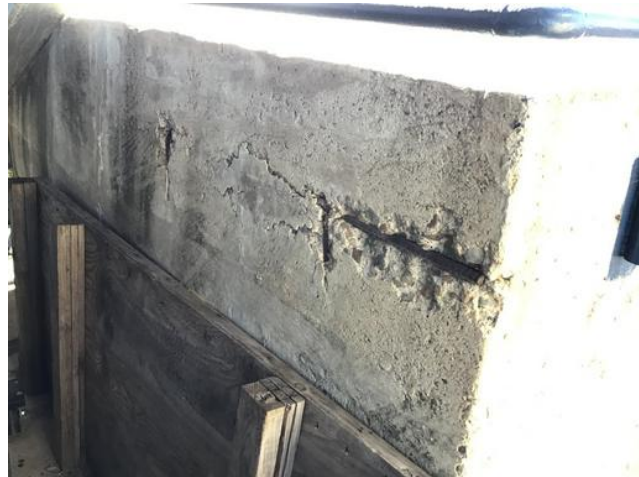
**Description**  
12 x 3 x 60 Concrete spalling  
due to edge distance of  
reinforcing

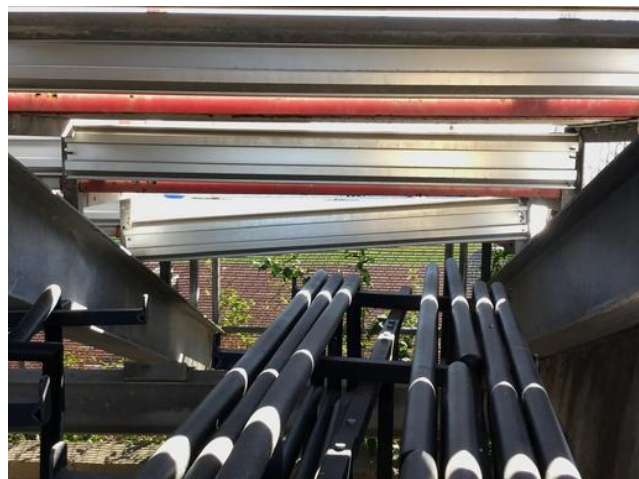
20220301\_092156\_photo  
**Simon Solorio**  
Mar 1, 2022 9:21 AM

Footer is damaged due to  
corrosion. Material red iron

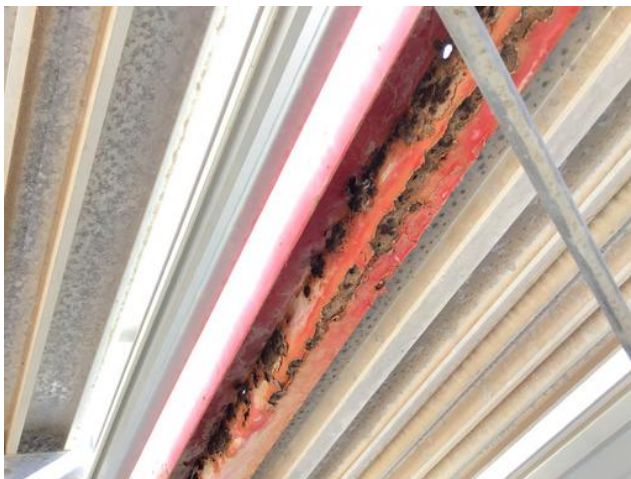
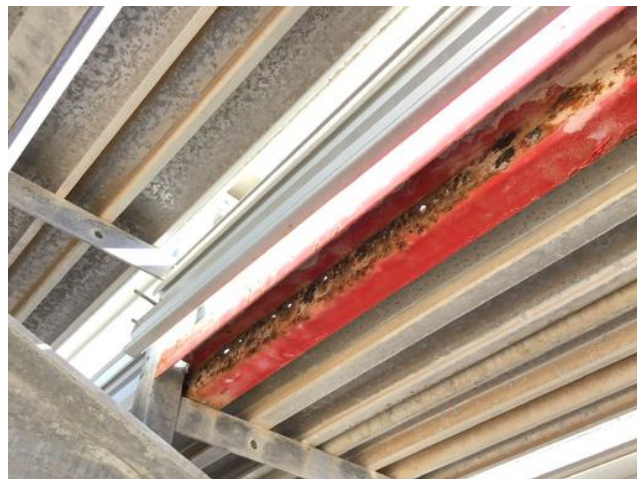
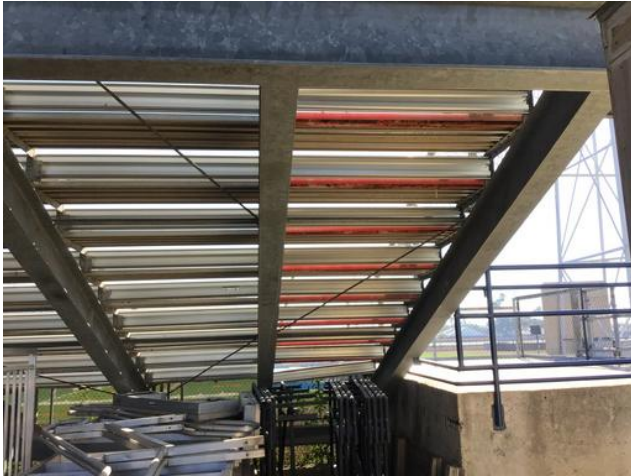
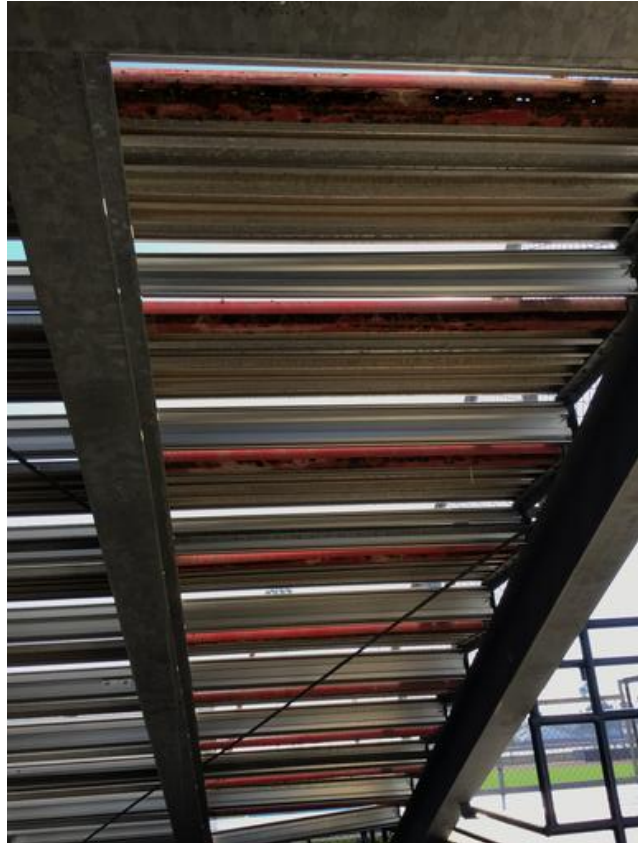
## #4 Angle

Design >  
Improper use of material  
type

9 Footer used is not  
aluminum and has corroded

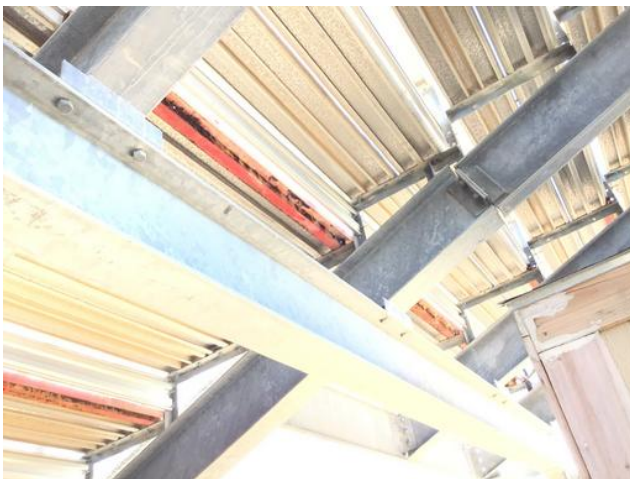
### #3 Angle

Design >  
Improper use of material  
type

3 Footer used is not  
aluminum and has corroded

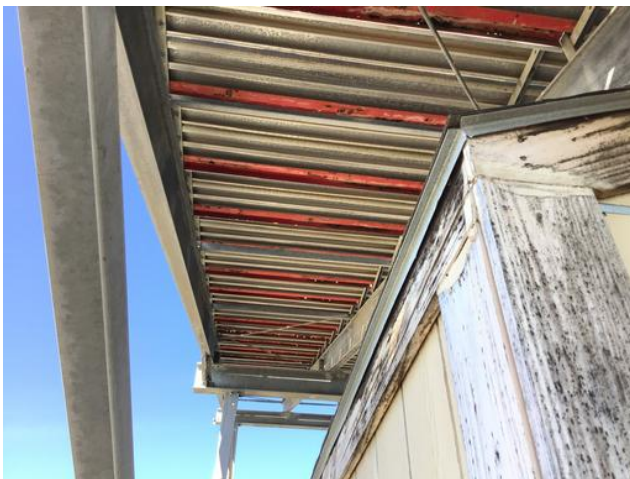
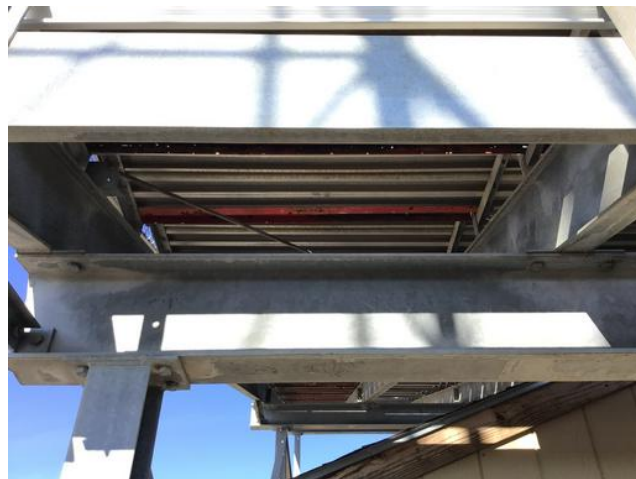
Design >  
Improper use of material  
type

22 Footer used is not  
aluminum and has corroded
