# ASBESTOS ABATEMENT SPECIFICATION

**Barrientes CTE Building  
1100 East Ebony Lane  
Edinburg, Texas 78504**

**November 29, 2023  
Terracon Project Number: 88237289**

Project: Barrientes CTE Building  
1100 East Ebony Lane  
Edinburg, Texas 78504  
Terracon Project No. 88237289

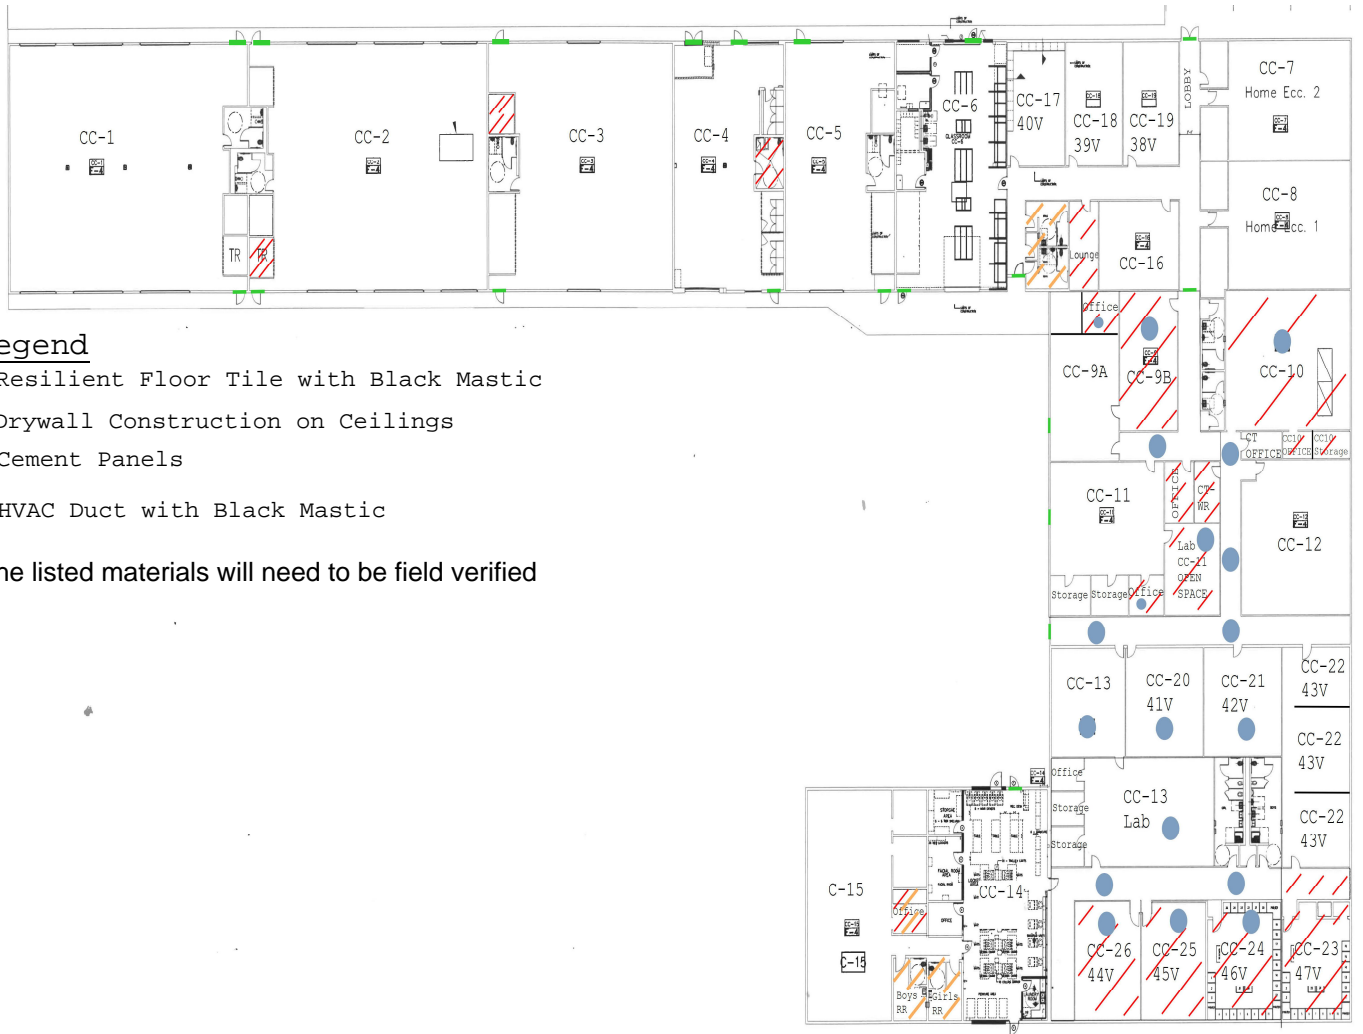
**Abatement Drawings**

**Legend**

- Resilient Floor Tile with Black Mastic
- Drywall Construction on Ceilings
- Cement Panels
- HVAC Duct with Black Mastic
